Captain Oliver Filley House Bloomfield, Connecticut

Cross-Section Microscopy Report

Date: December 2, 1999

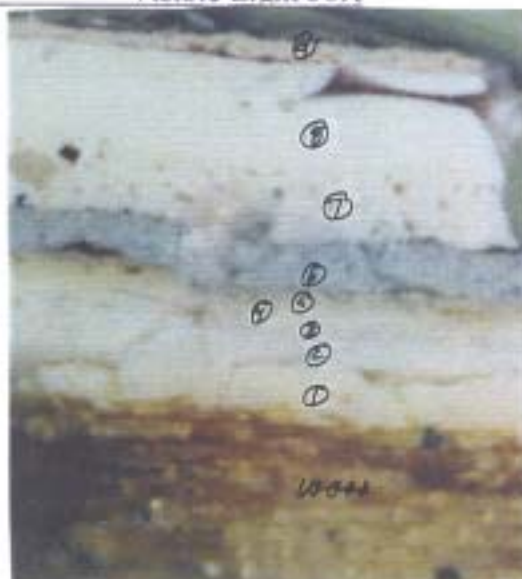
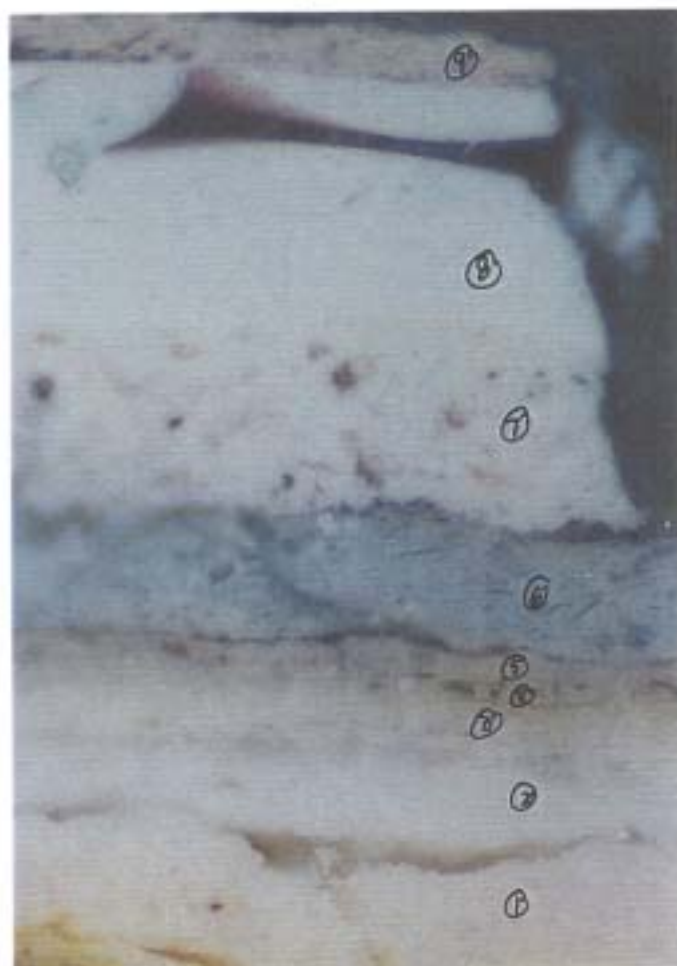
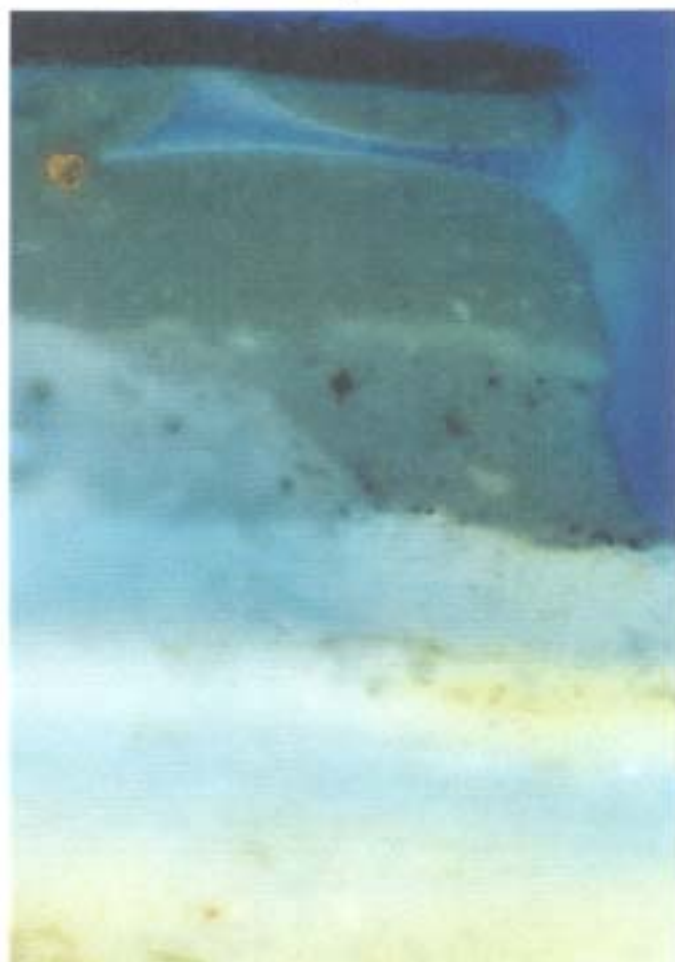
Sample 101: South Wing, South Room/Base -- NE Corner ca. 1834

Sample 101: South Wing, South Room/Base – NE Corner ca. 1834. The paint sequence in this sample consists of ten generations of paint beginning with an off-white layer directly above the wood substrate. The thickness of the layers varies considerably over time, but the first off-white generation is comparatively thick and intact. It is oilbound and has a yellowish autofluorescence color in reflected ultraviolet light, which appears to be consistent with aged oil paints containing the pigment white lead.

The majority of the layers in this sample are off-white or cream-color, although in the sixth paint generation this element was painted blue-gray. This paint sequence may represent the complete paint history in this room since 1834, as there are no signs of stripping or paint flaking in this sample.

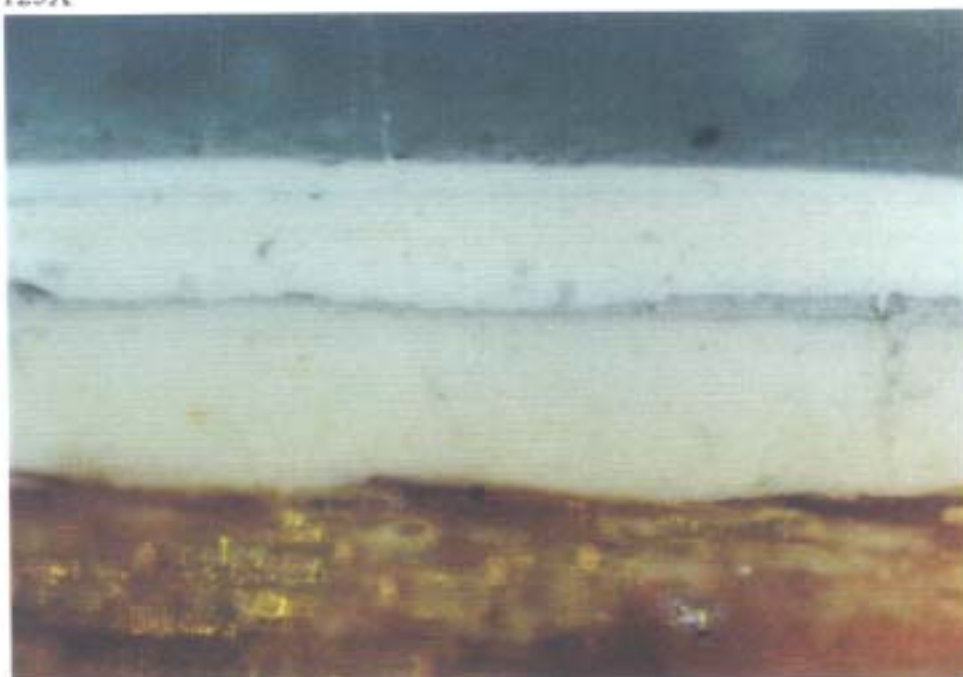
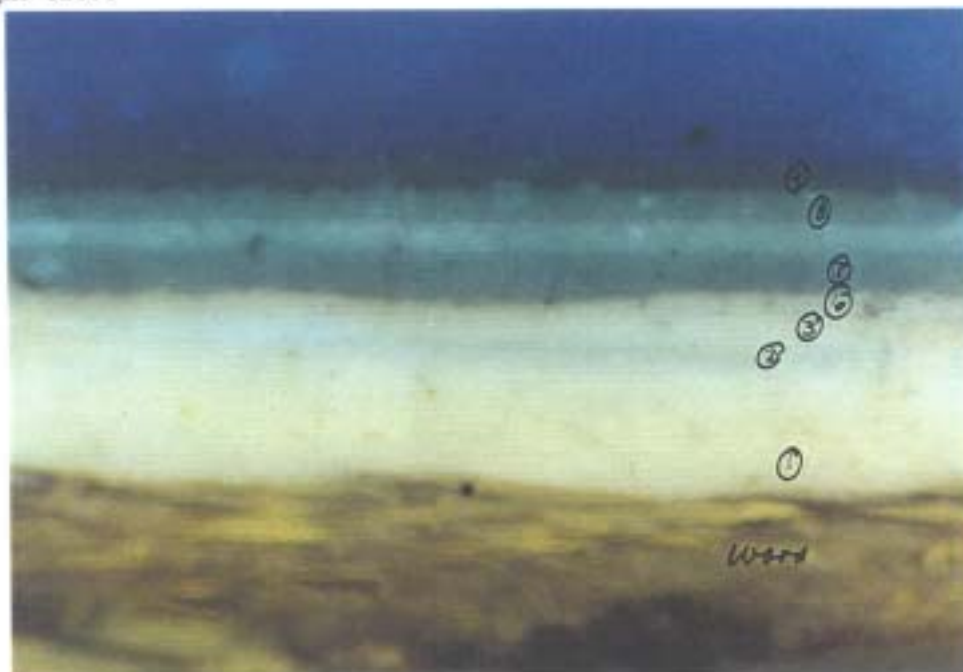
Sample 102 – South Wing, South Room/Sash (6/6) SE ca. 1834

Sample 102 – South Wing, South Room/Sash (6/6) SE ca. 1834. This sample can be directly compared to sample 101 from the same room. There are seven generations of paint in this sample, beginning with the same three layers of off-white, white, and cream-color paint identified in sample 101. This paint sequence is missing generations 4 and 5 (thin dark cream-colored paints). The comparative paint histories suggest the base and sash in this room date to the same period.

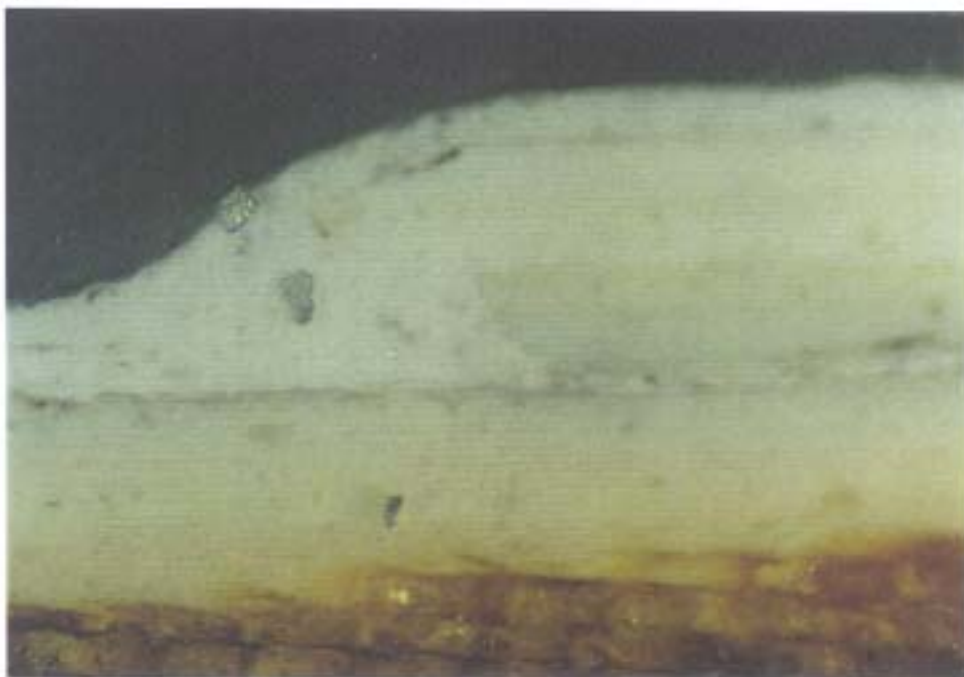
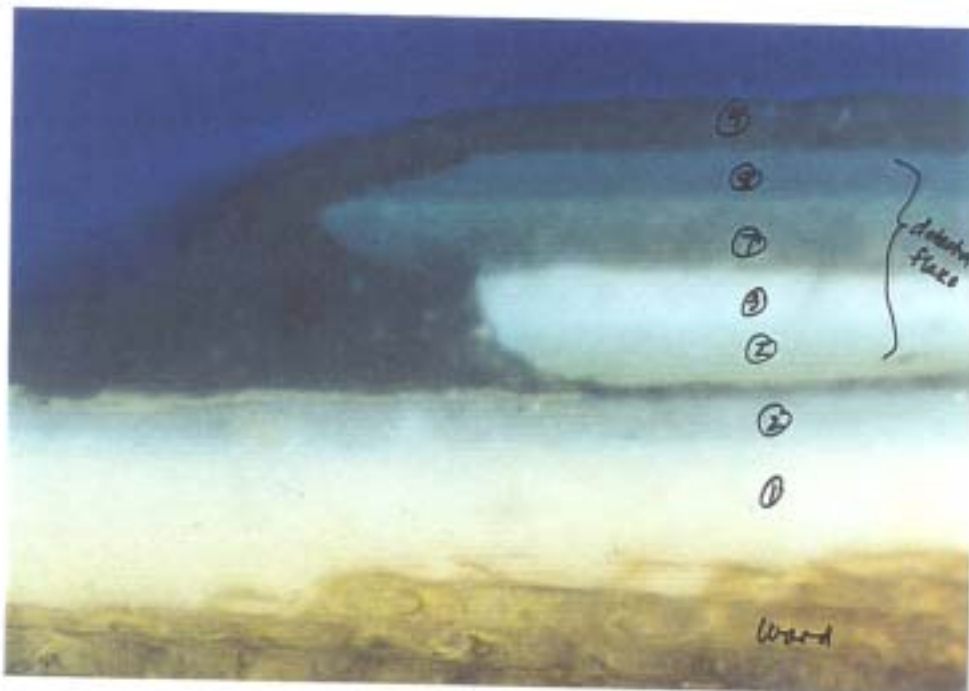
Sample 103 -- South Wing, South Room/Window Trim SW ca. 1834

Sample 103 – South Wing, South Room/Window trim SW ca. 1834. The paints in this sample are somewhat more disrupted than in the other samples from this room, but the evidence suggests the window trim was initially painted the same off-white as the baseboard and the sash. Compared to sample 101 this sample contains generations 1, 2, 3, 7, 8 and 9. The paint sequence in the photomicrographs shows a flake of paint containing generations 2, 3, 7, and 8 that is out of position and trapped by the most recent white paint layer applied to the window trim.

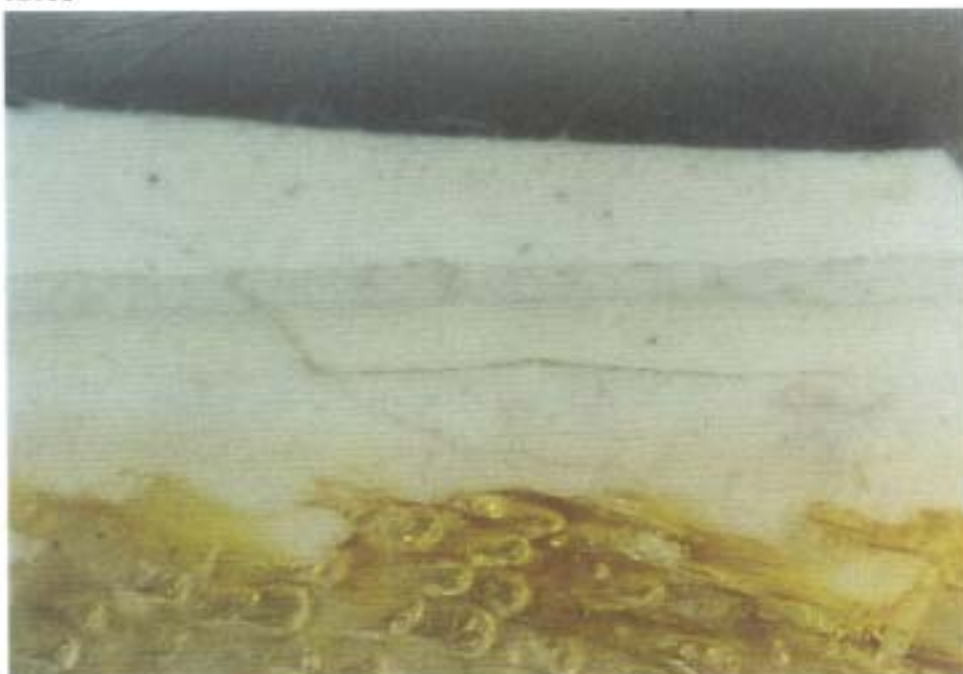
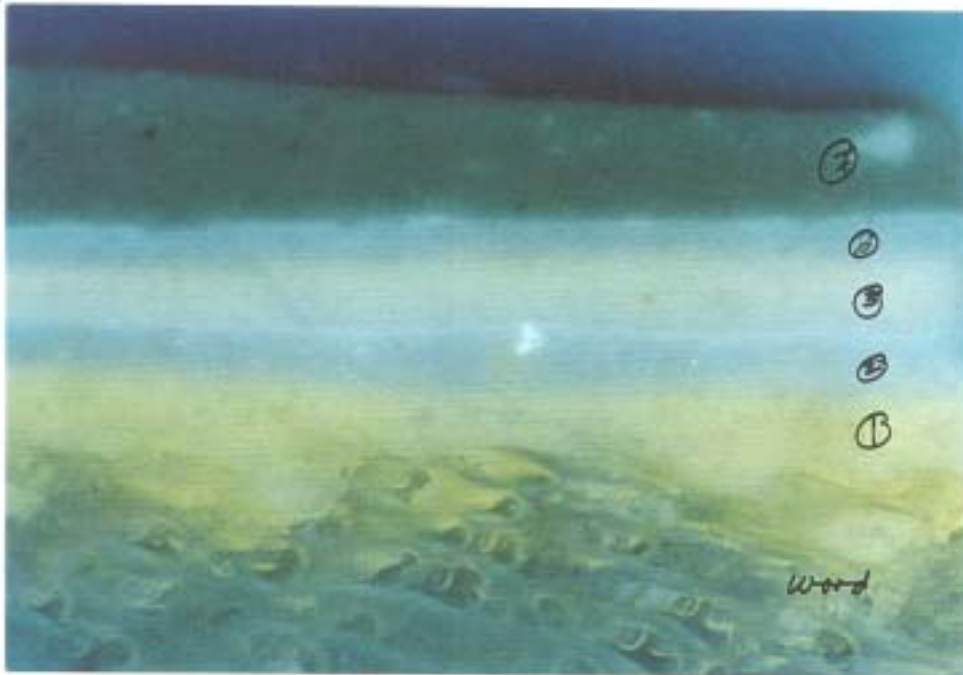
Sample 104 -- South Wing, South Room/Mantel NE ca. 1834

Sample 104 – South Wing, South Room/Mantel NE ca. 1834. There are five generations of paint in this sample, beginning with the same off-white paint found as the first generation in the other three samples from this space. When this cross-section is compared to sample 101 from the baseboard, it appears to contain generations 1, 2, 3, 6 and 7. Generation 6 is blue-gray in sample 101 but it is a very pale gray in this sample.

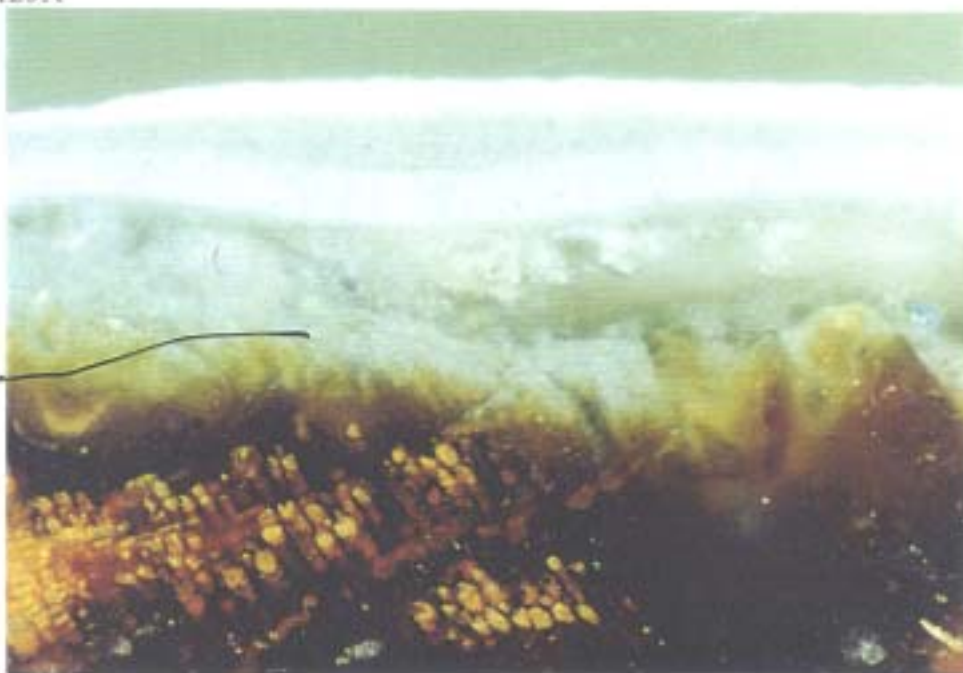
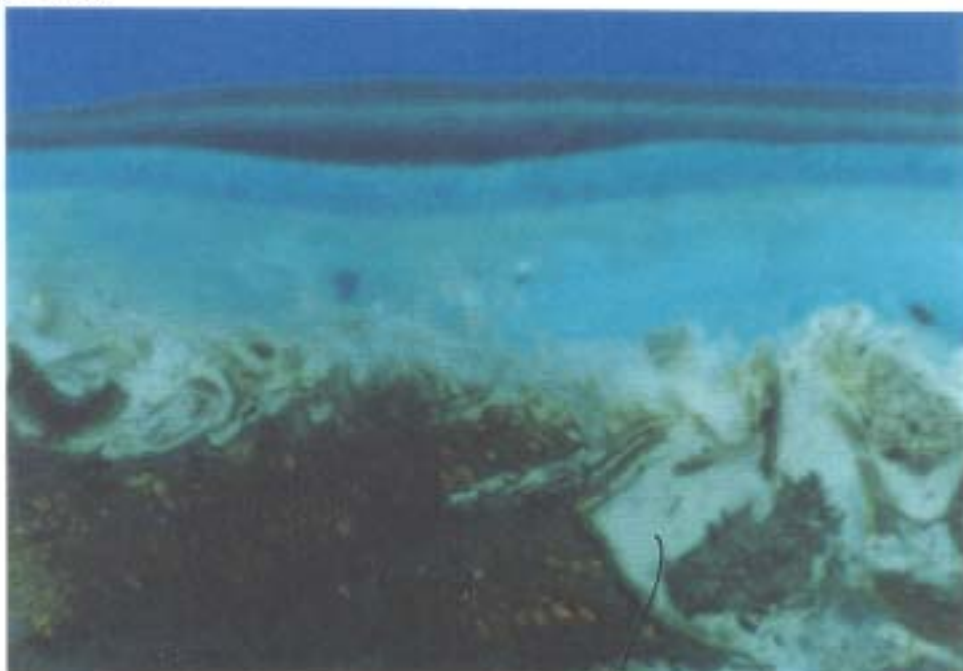
Sample 105 -- Main Entry Stair/Rail N, late Victorian

Sample 105 – Main Entry Stair/Rail N, late Victorian. The evidence in this sample is quite disrupted, perhaps due to chemical stripping. However, it appears the earliest coating on the rail still survives. The first coating on the wood appears to be an unpigmented plant resin varnish coating, based on its whitish autofluorescence in ultraviolet light and translucent tan appearance in visible light. The surface of this varnish is uneven and inconsistent, perhaps as a result of being partially stripped or sanded. There is a modern, incomplete gray paint above the varnish remnants, followed by two generations of modern white paint. This limited paint chronology is not helpful for comparative dating purposes, but it does suggest the rail was originally varnished, not painted.

*remnants of
gray paint*

*plant resin
Varnish*

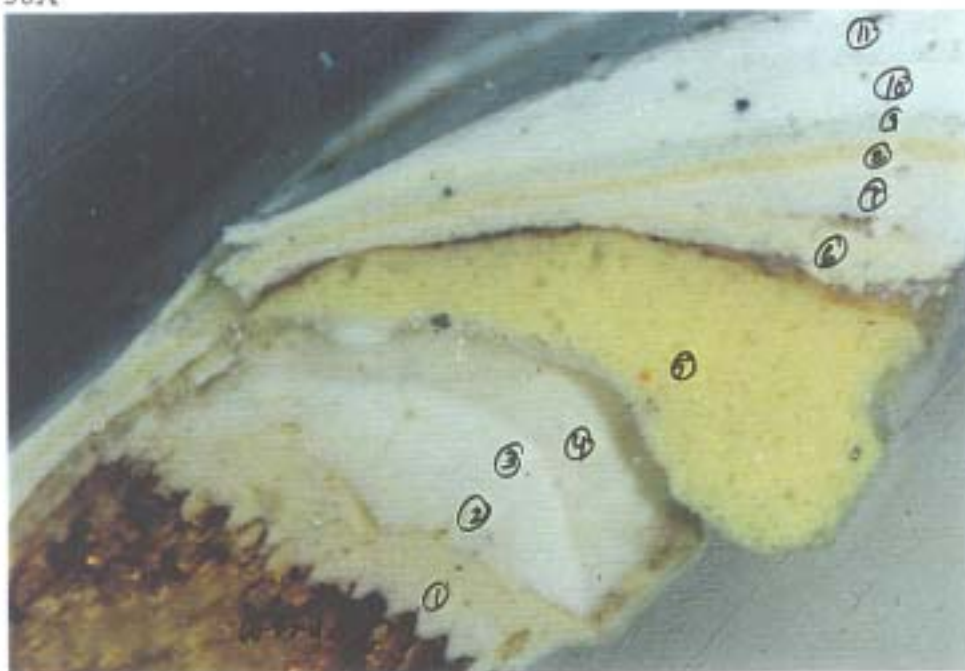
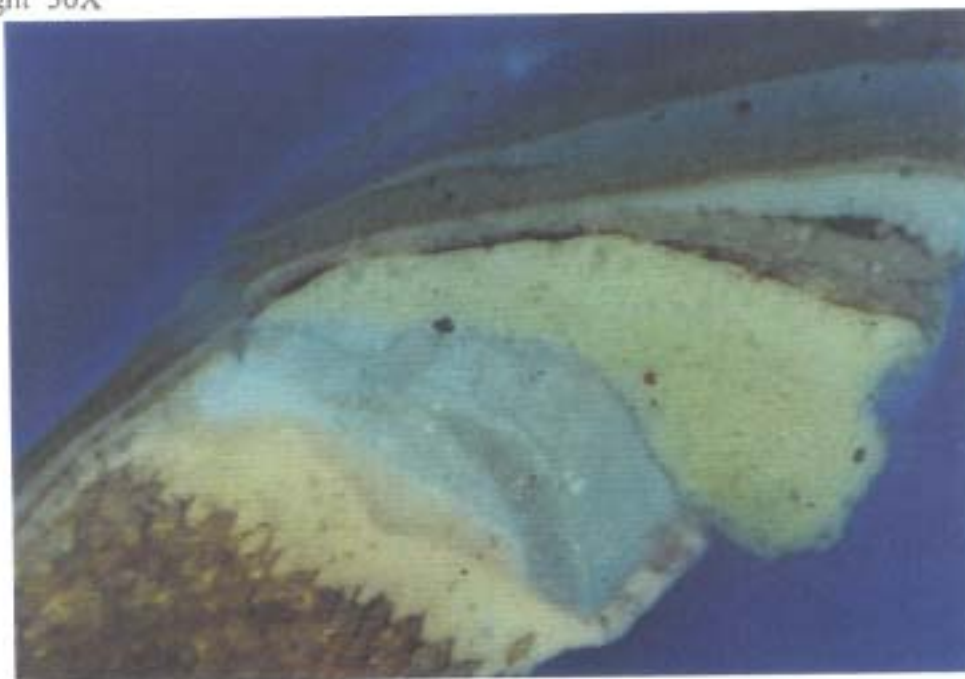
Sample 106 -- Main Entry Hall/Door Frame SE, late Victorian.

Sample 106 – Main Entry Hall/Door Frame SE, late Victorian. This sample contains approximately eleven generations of paint beginning with a leanly oilbound cream-colored paint. This door frame is identified as late Victorian by Eloise Marinos, however, it appears not to contain any of the paint layers found on the earlier elements in the south wing, so it is not possible to determine how many paint generations were applied between 1834 and the time when this door frame was installed.

Generation 5 in this sample consists of a yellow base coat and a red-brown glaze, which may represent a graining treatment applied in the twentieth century. A similar graining treatment was identified as the fourth paint generation in sample 206 from a four-panel door in the south wing north room. This door was identified as possibly dating to 1834. The relative position of this graining treatment on an earlier door may indicate that the second floor was not repainted as frequently as the first floor, or perhaps the earlier door was removed from its original position.

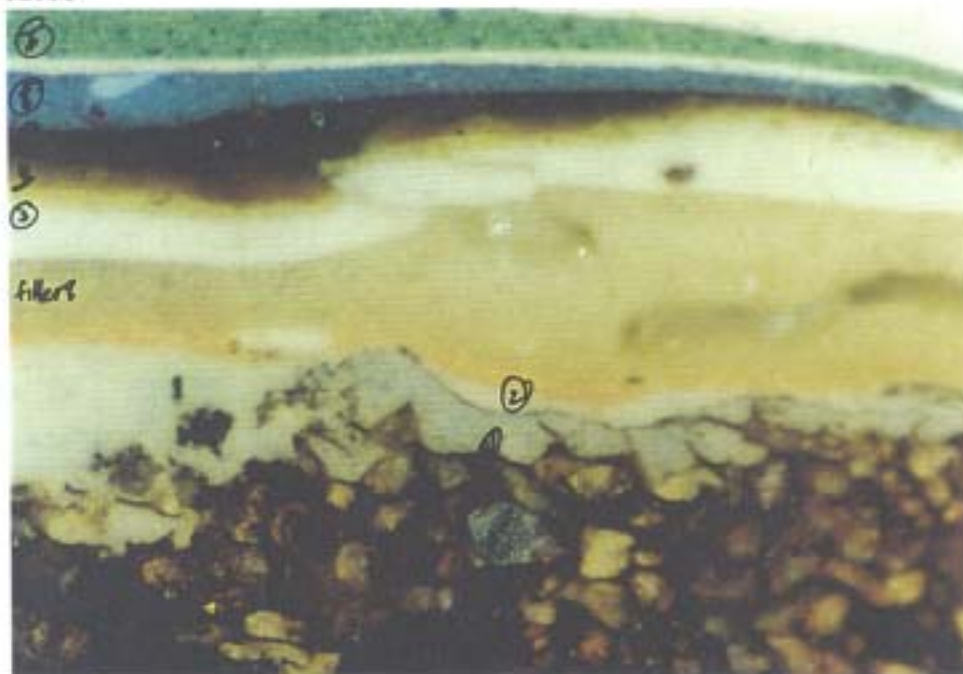
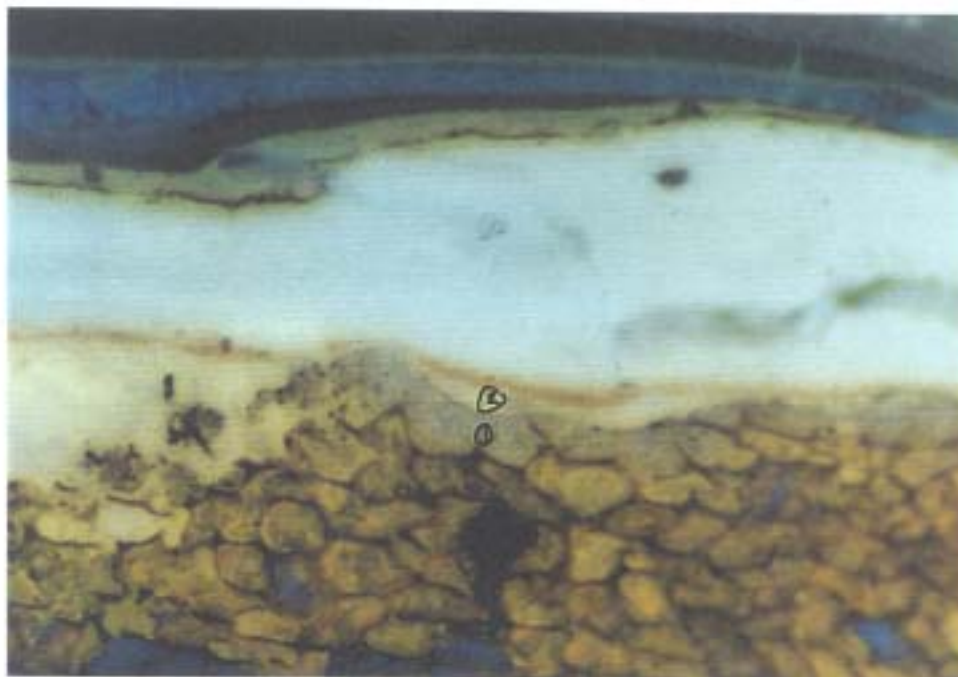
Sample 107 -- East Wing Kitchen/Door Frame SE facing, later.

Sample 107 – East Wing Kitchen/Door Frame SE facing, later. This sample contains approximately eleven generations of paint, beginning with a gray paint layer that appears to be partially stripped off. There is evidence of a shellac sealant (orange autofluorescent material trapped in the wood fibers) applied to the wood before the door frame was painted. The second generation consists of cream colored primer and a pale tan-orange finish. The third generation of paint was applied on top of a thick cream-colored filler layer and it consist of a white primer, a yellow base coat and a brown glaze with a plant resin varnish coating. This third generation may represent a grain-painting sequence. In the fourth generation the door frame was painted with a thin layer of brown paint.

The first generation gray paint appears to be the same type of paint identified as the sixth paint generation in samples 101 and 102, both original 1834 elements from the south wing.

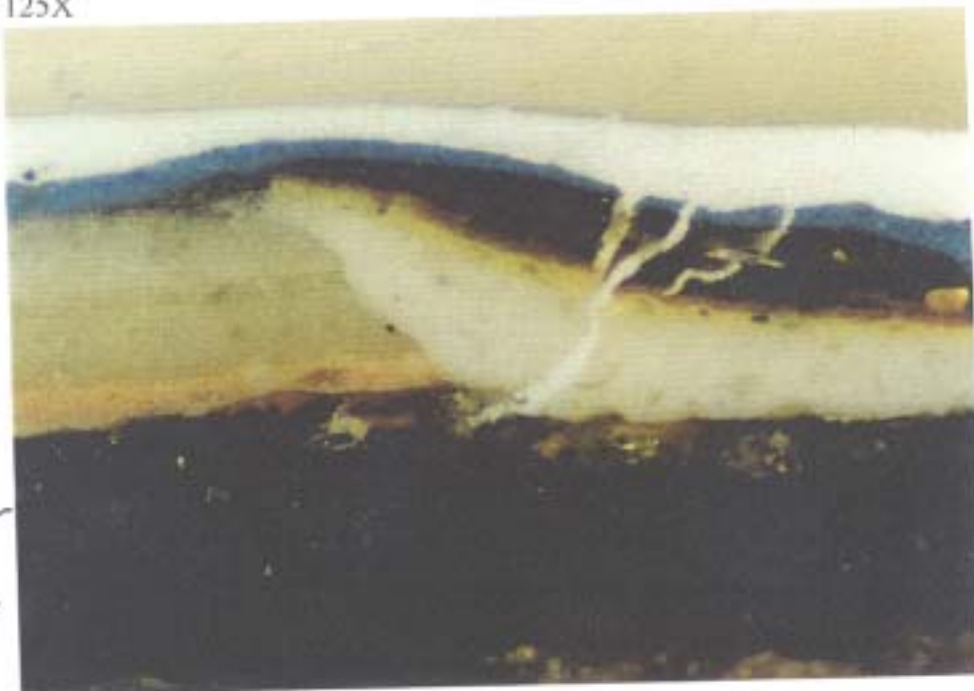
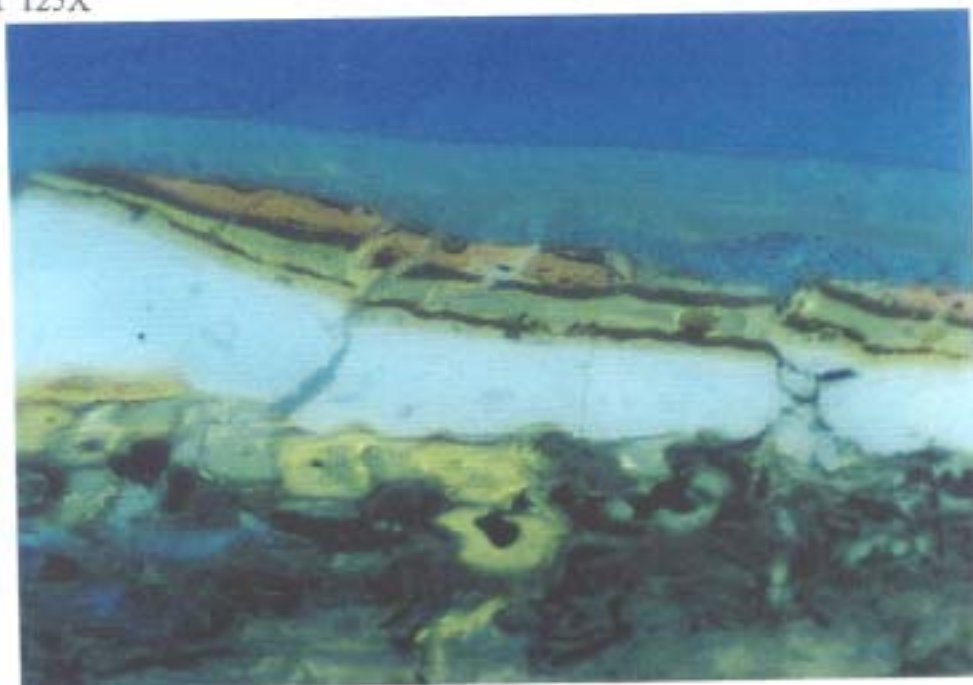
Sample 108 -- East Wing Kitchen/Base NE facing, later.

Sample 108 – East Wing Kitchen/Base NE facing, later. The wood substrate in this sample is blackened and the wood cells are crushed. This suggests this particular element was exposed to fire and the first paint generation was lost. The likelihood of fire damage is reinforced when the paint sequence is compared to sample 107 from the door frame in the same room. The paint layers in sample 108 can be lined up to match seven of the nine paint generations in sample 107, but the first gray paint found on the door frame is missing in the sample from the base.

It is possible that the first paint layer on the base is missing simply due to abrasion. But the charred appearance of the wood does suggest fire damage early on. According to the "Paint Sample Key" marked with the sample locations, sample 108 was taken from an area that is not near a fireplace.

*charred wood
substrate*

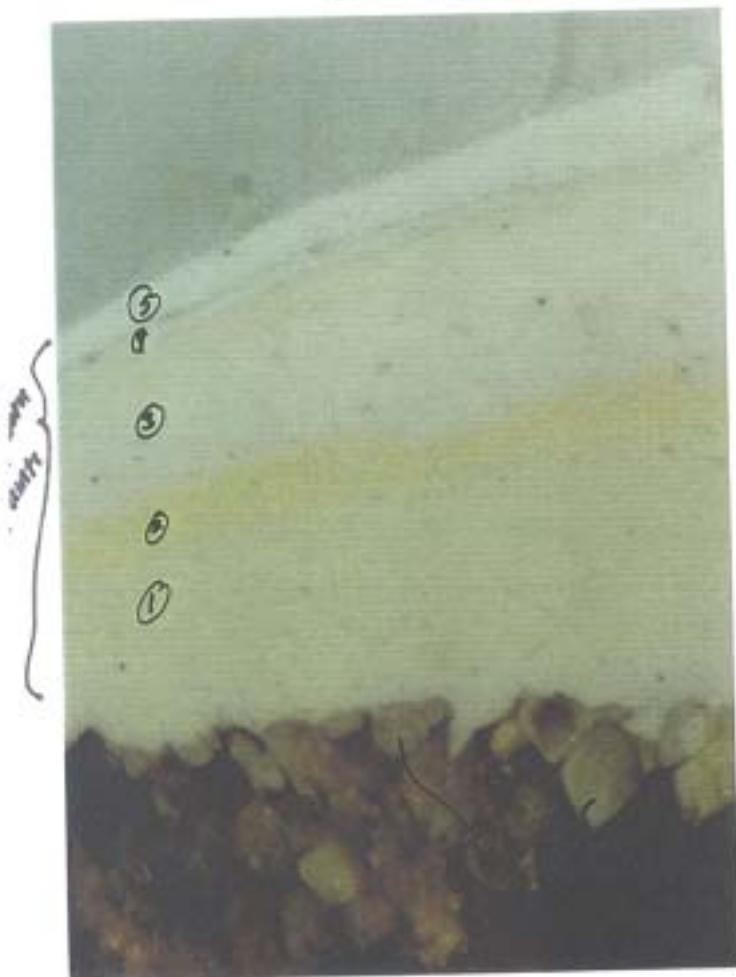
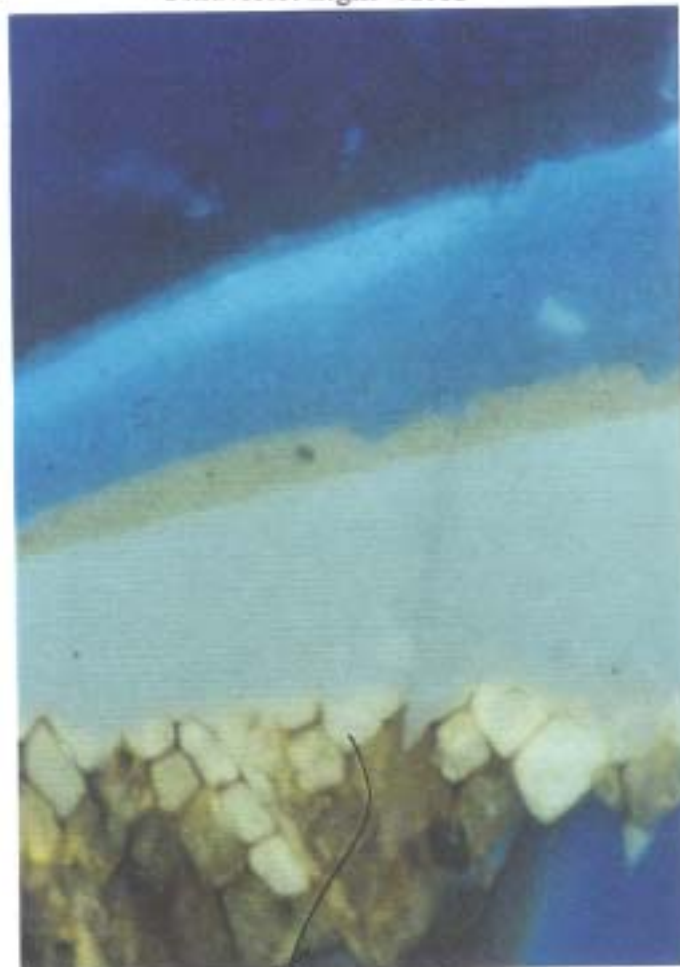
Sample 201 -- East Wing Southwest Room/Sash (12/8) NE, 1834-mid1850s

Sample 201 – East Wing Southwest Room/Sash (12/8) NE, 1834-mid1850s. The evidence in this cross-section indicates the sampled area of sash does not retain early paint evidence. This may be due to the paint having been scraped off as there is an off-white paint (perhaps a primer) trapped in the wood fibers, but this paint is not present as an intact layer above the wood. The wood substrate also has a weathered appearance, suggesting it was left unpainted for a long period of time. There are five generations of modern, finely ground, nonfluorescent paint layers above the wood substrate.

remnants of
earliest
paint

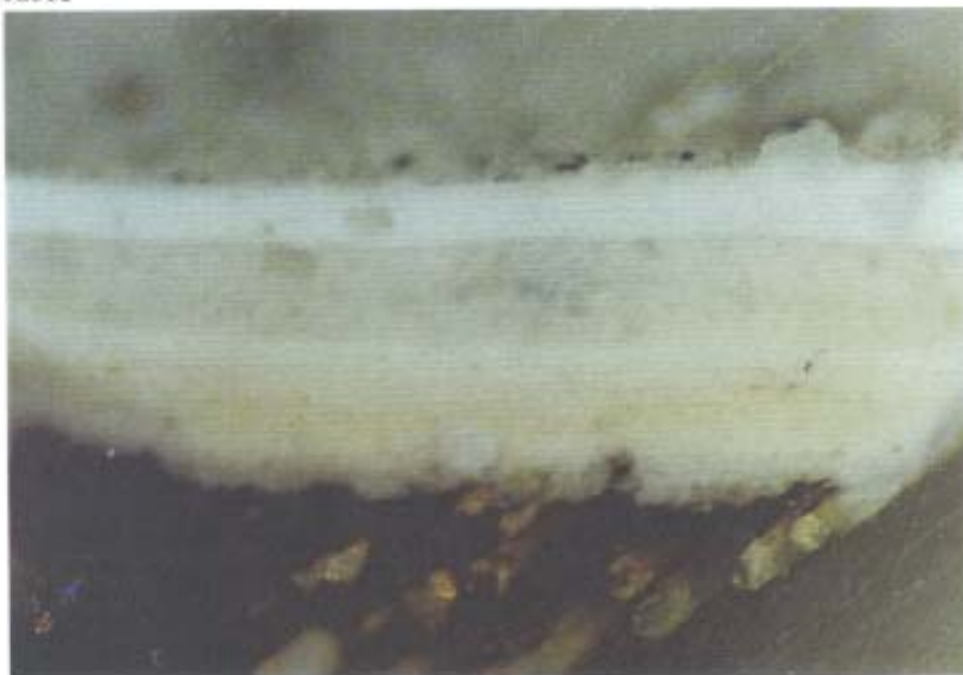
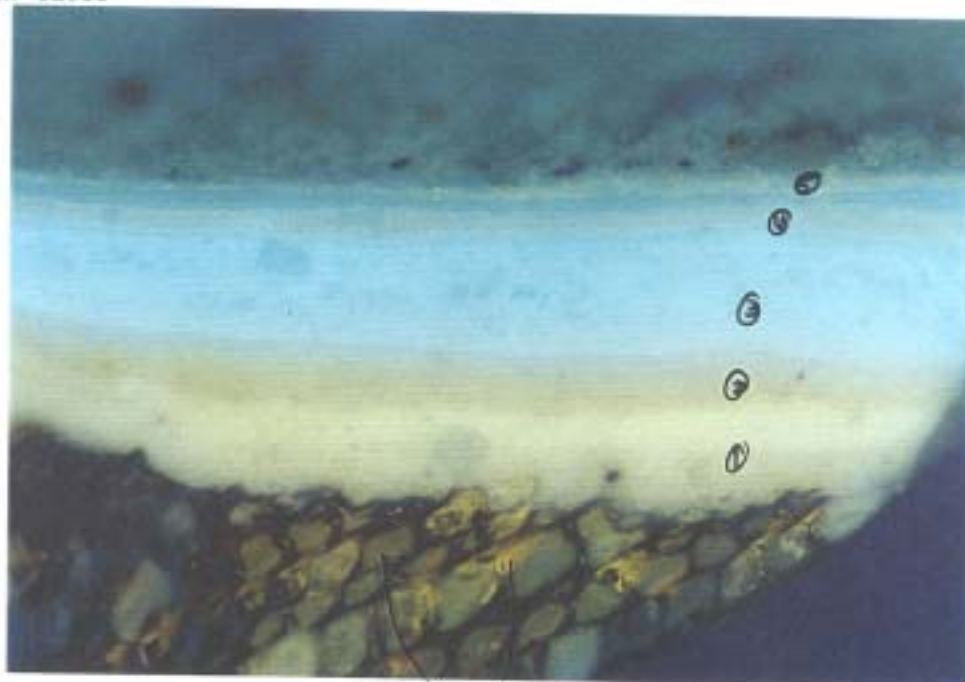
Sample 202 -- East Wing East Room/Base @ Dividing Wall W, 1834-mid 1850s.

Sample 202 – East Wing East Room/Base @ Dividing Wall W, 1834-mid 1850s. This sample contains five generations of paint above a wood substrate that was sealed with shellac before painting. The first layer above the wood is a cream color followed by four generations of off-white. There is no clear evidence that earlier coatings have been removed, but the five paint layers appear surprisingly clean and unweathered for the projected age of this element. Compared to other samples taken from the second floor, this cross-section sample contains considerably fewer paint generations, but the first two oilbound paint layers in this sample do appear similar to the early paints found on other base elements examined in this study.

shellac in
wood

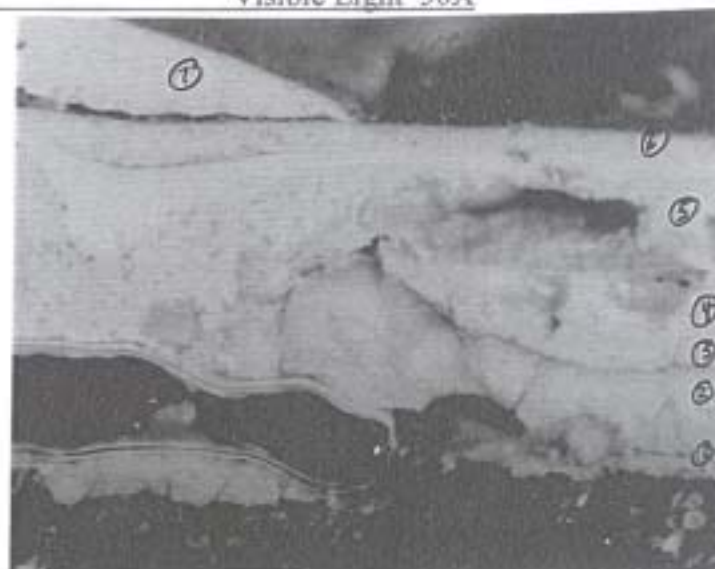
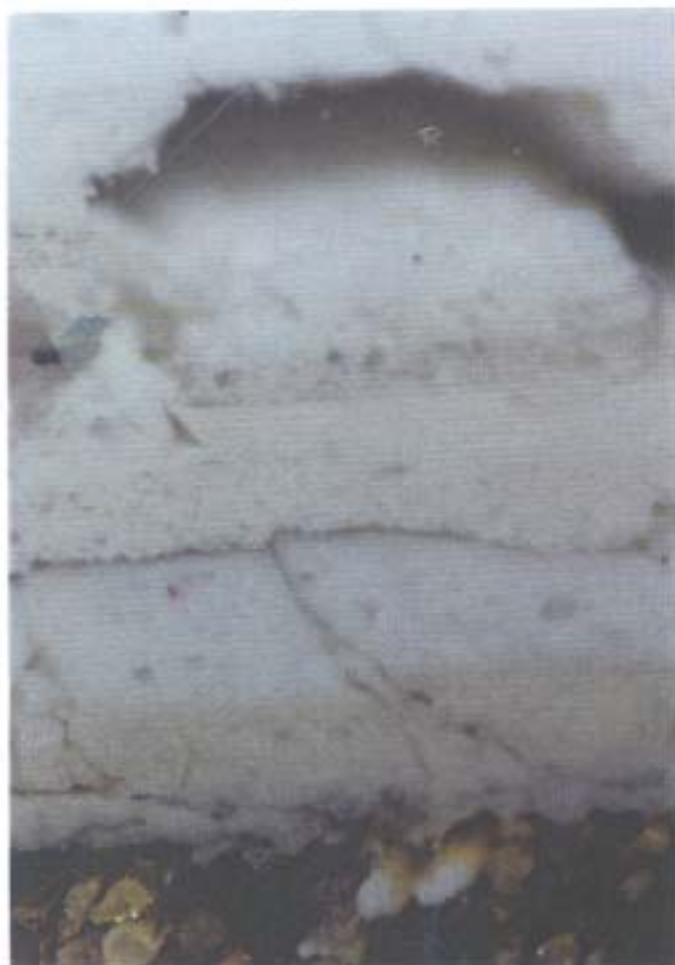
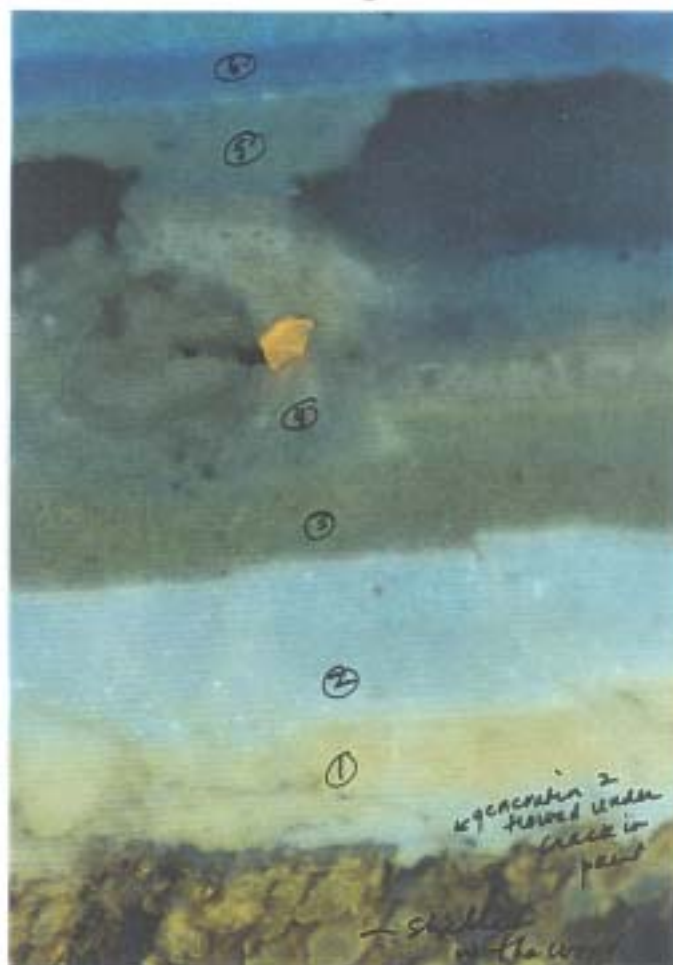
Sample 203 -- South Wing South Room/Door Trim SE facing, late Victorian

Sample 203 – South Wing South Room/Door Trim SE facing, late Victorian. There are seven generations of paint on the door trim, beginning with a cream-colored paint, followed by six generations of white and off-white paint. It is somewhat difficult to distinguish between these layers in visible light, but the layers have distinctive autofluorescence colors in ultraviolet light that makes them more decipherable. The earliest layer appears to be a traditional oilbound paint. The paint sequence is disrupted as though the trim had been partially scraped before applying the fifth generation off-white paint.

When this paint sequence is compared to sample 202, it appears that the first generation cream color in this sample lines up with the second generation cream color in sample 202, a base identified as dating from 1834 to the 1850s.

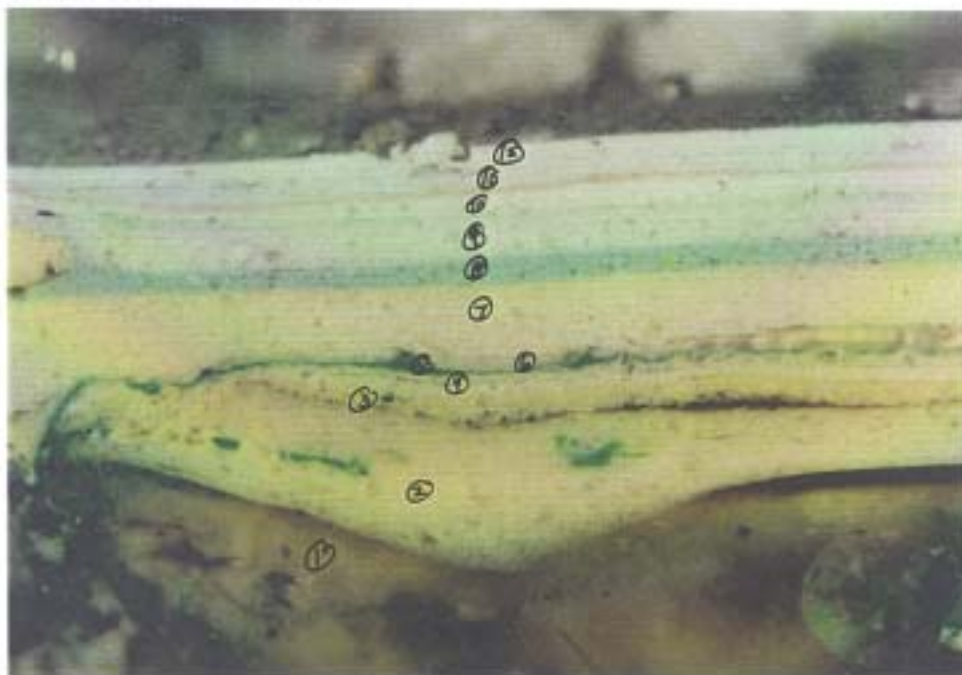
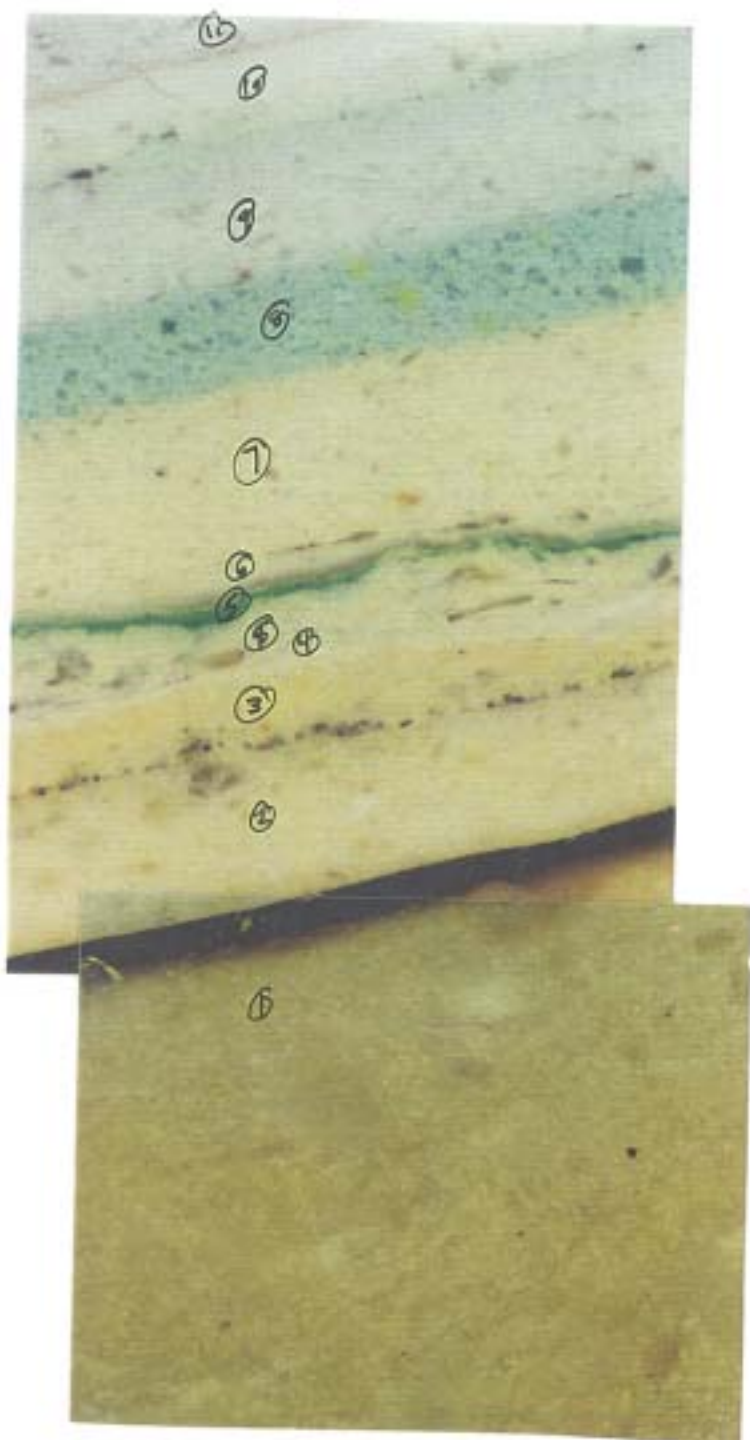
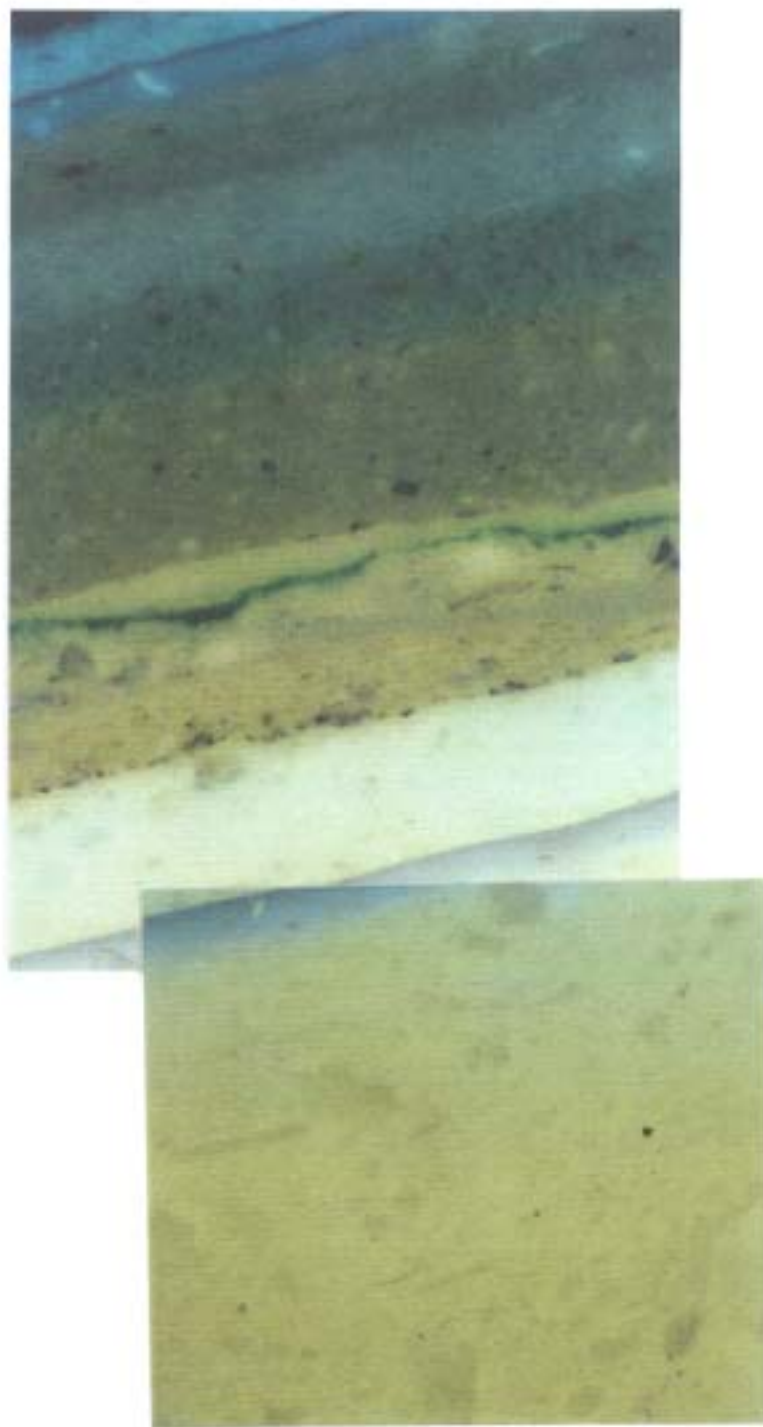
Sample 204 -- South Wing South Room/Base SE, late Victorian

Sample 204 – South Wing South Room/Base SE, late Victorian. The cross-section from the base contains approximately twelve generations of paint, but the paint layers on this base element do not appear to relate to the paints found on the door trim (sample 203) or on the sash (sample 205). The sequence begins with a thick cream-colored paint layer, which has a varnish coating. The second and third generations are also cream-colored paints, followed by a coarse off-white paint. Generations five (bright green) through twelve (white) appear to be comparatively modern, finely ground, nonfluorescent paint layers.

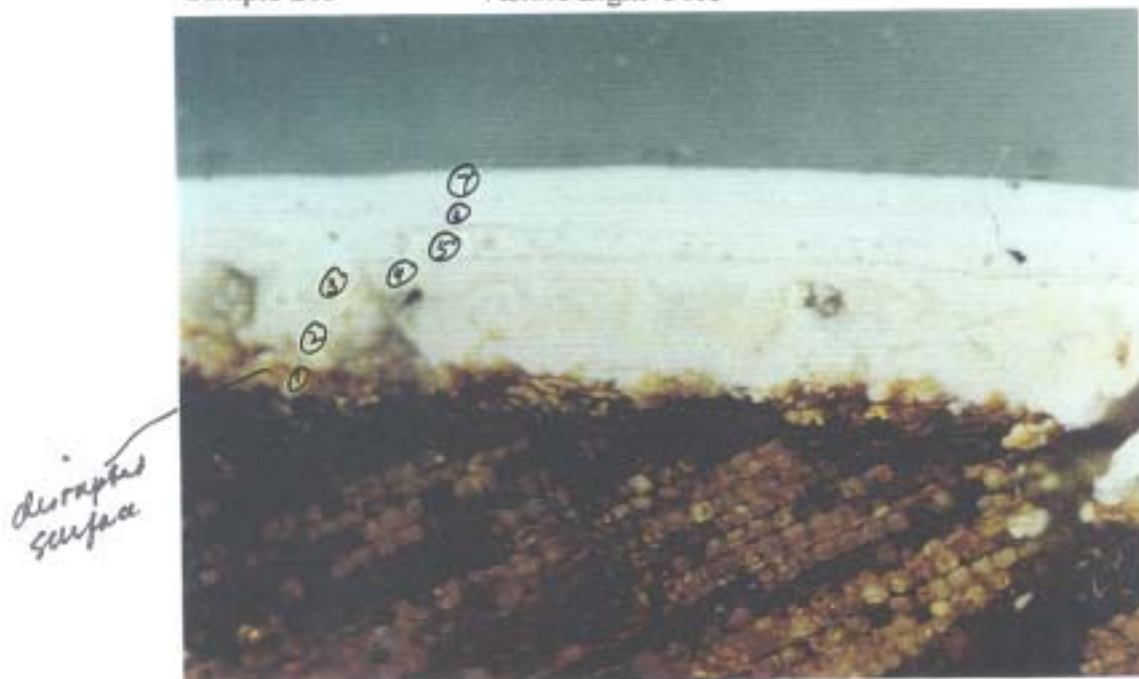
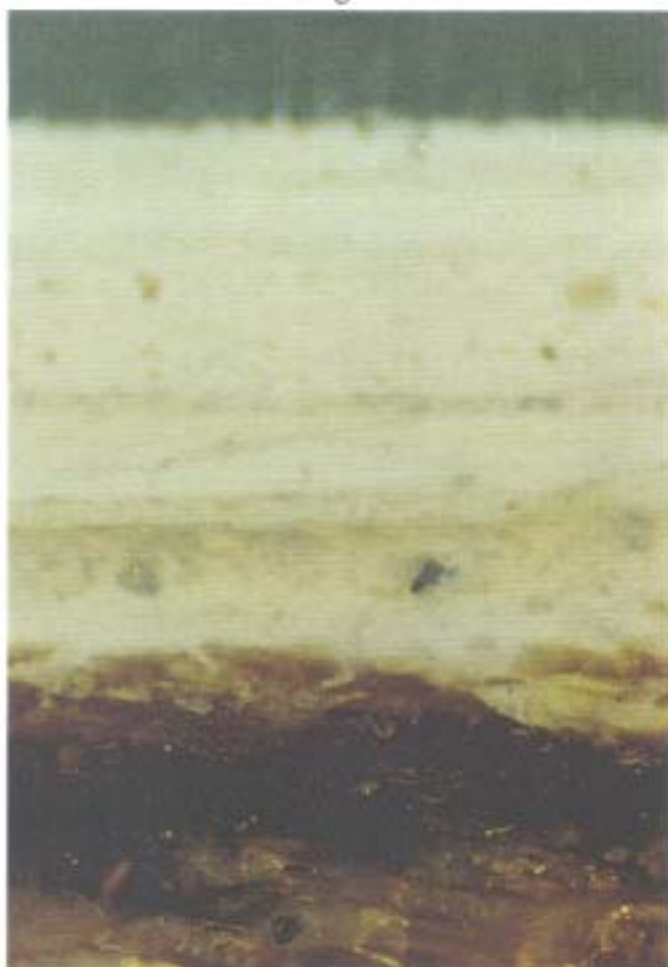
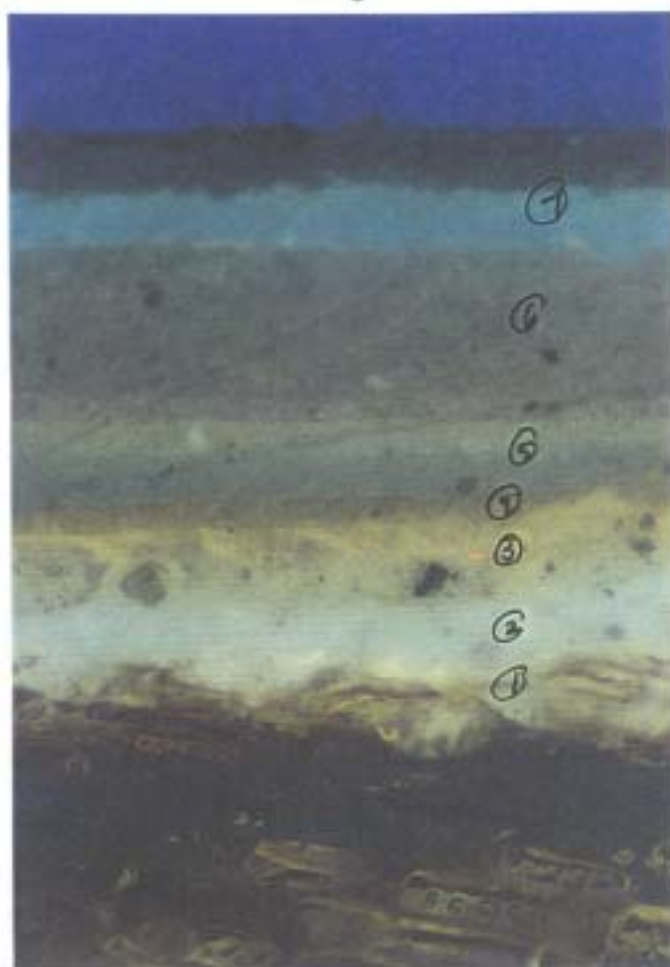
Sample 205 -- South Wing South Room/Sash (6/6) SE, late Victorian

Sample 205 – South Wing South Room/Sash (6/6) SE, late Victorian. The wood substrate in this sample is slightly disrupted and uneven, suggesting the early paints may have been partially scraped away. Despite this disruption, there is fragmentary evidence that the sash was first painted with the same cream-colored paint identified in sample 203 from the door trim. When the paint histories in samples 203 and 205 are aligned, it appears these two elements were painted the same colors each time the room was repainted.
