Captain Oliver Filley House Bloomfield, Connecticut

Cross-Section Microscopy Report

Date: December 2, 1999

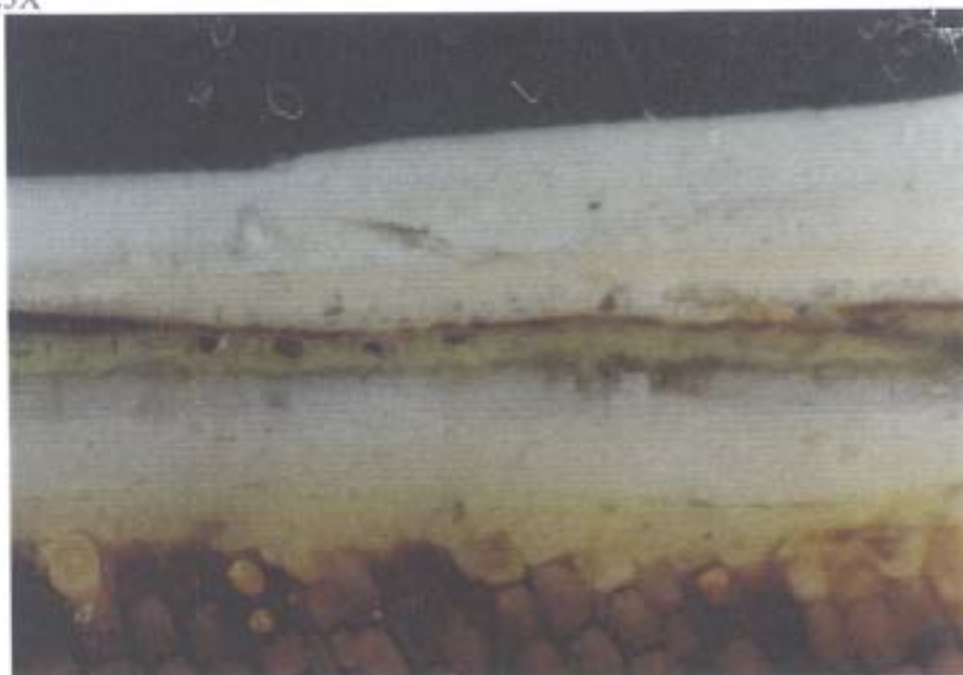
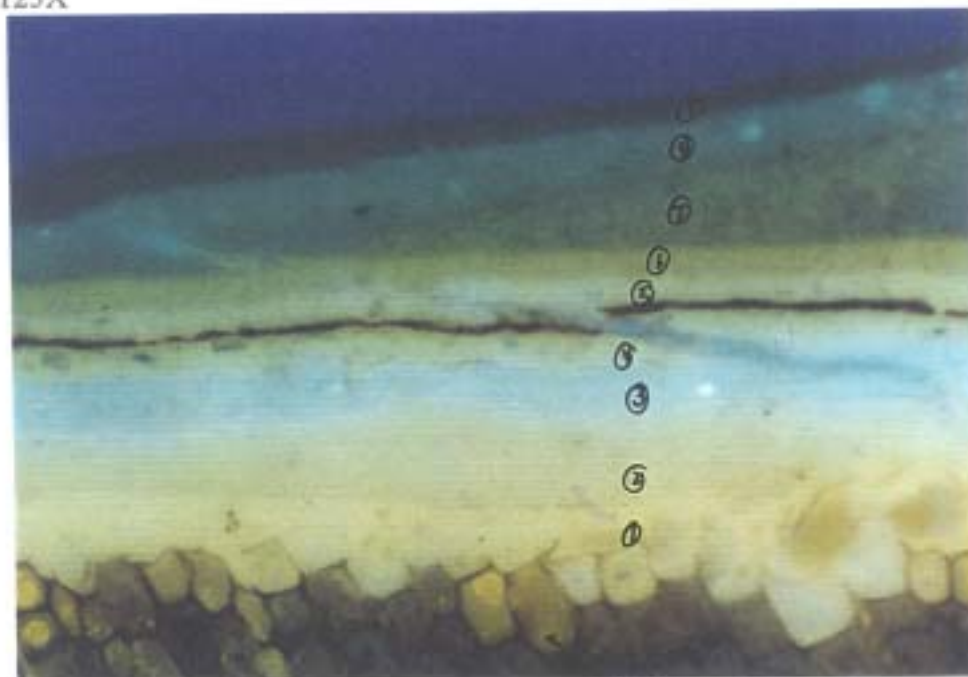
Sample 206 -- South Wing North Room/4 panel door NW, 1834?

Sample 206 – South Wing North Room/4 panel door NW, 1834? The cross-section from the north room door appears to represent a complete paint history with eight generations of paint. The paint sequence begins with a leanly oilbound cream-colored paint layer that is similar to the first cream-colored paint layer in sample 202 from the east wing (dated 1834-1850s). The second paint generation is off-white, followed by white paint in the third generation. The fourth generation appears to be a graining treatment similar to the graining identified as the fifth paint generation in sample 106, taken from a late Victorian door frame on the first floor.

Shellac in wood

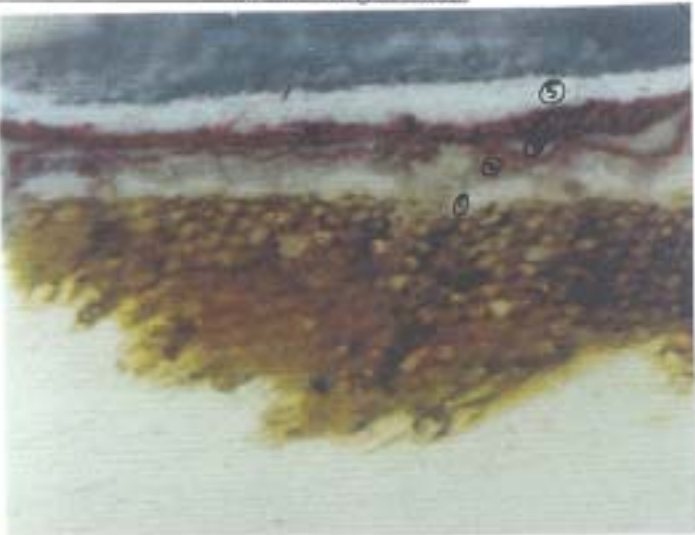
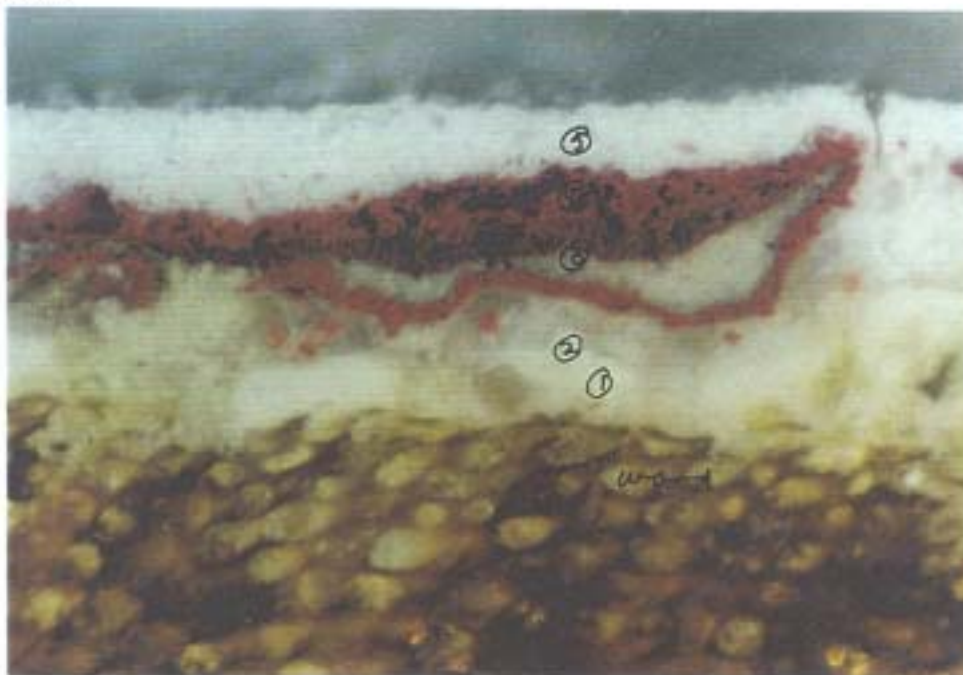
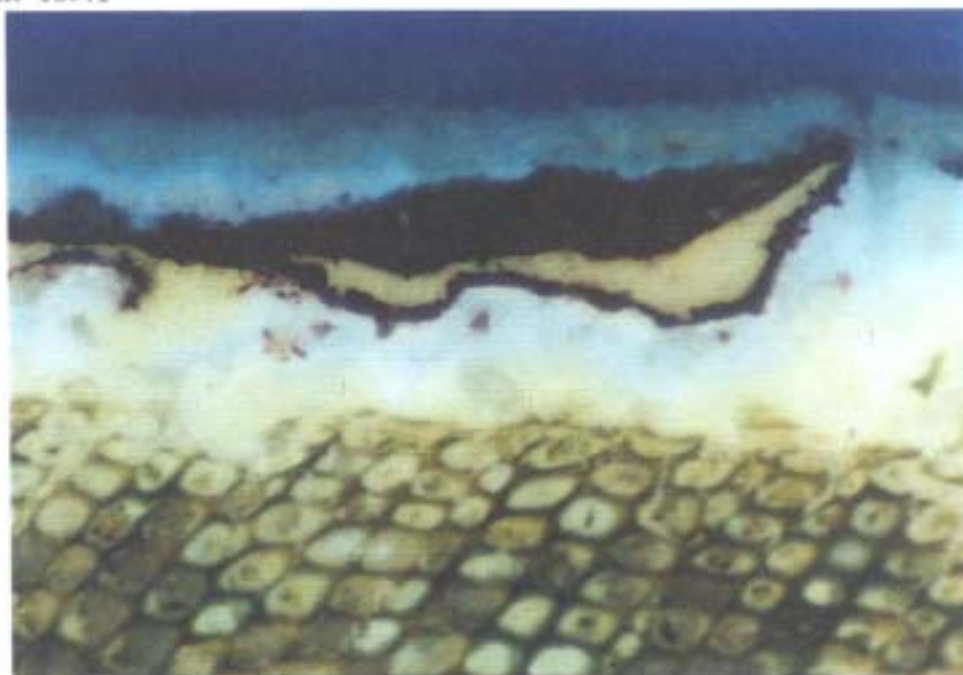
Sample E01: *South Wing First Floor/Southeast Sash SE, 1834.*

Sample E01: South Wing First Floor/Southeast Sash SE, 1834. It is generally difficult to obtain sash samples with complete paint sequences, in part due to the extreme weathering and condensation conditions which sashes are exposed to, and in part because the paint layers on sashes in regular use tend to be abraded or to flake off because of movement of the wood substrate. This sash sample contains only five generations of paint, which is not enough to represent a full exterior paint sequence from 1834, particularly when compared to the more intact paint sequence in sample E04 from the arch column with sixteen generations of paint. The arch column was identified by Eloise Marinos as a later architectural element.

The first generation of paint in this sample is off-white, which does appear consistent with the earliest paints found in sample E05 from an east wing upper sash. Sample E05 contains eleven generations of paint, and importantly, the second, third and fourth generation paints in sample E01 line up with the third, fifth and seventh paint generations in sample E05.

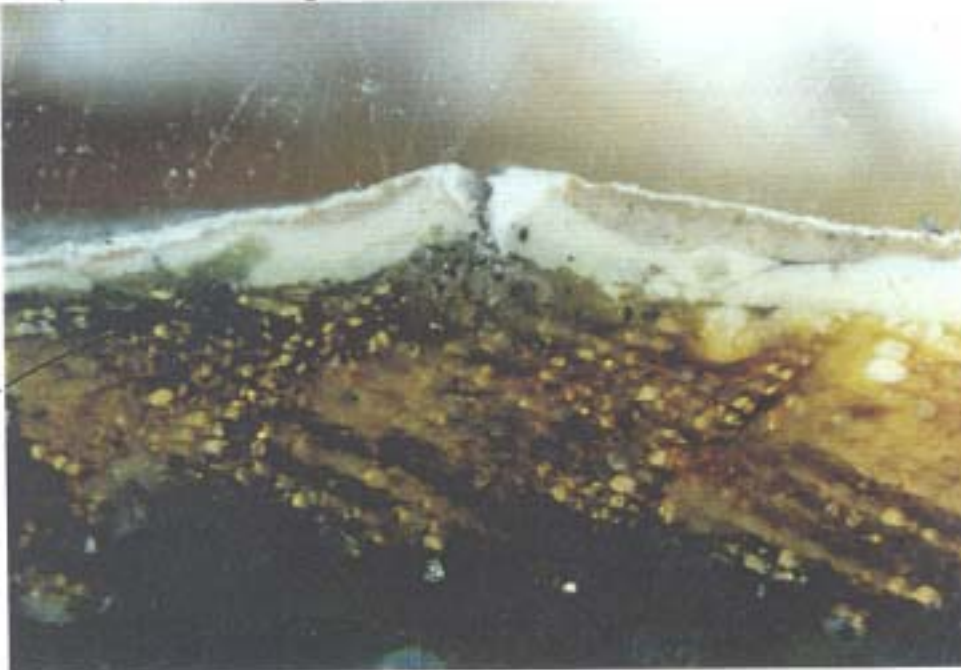
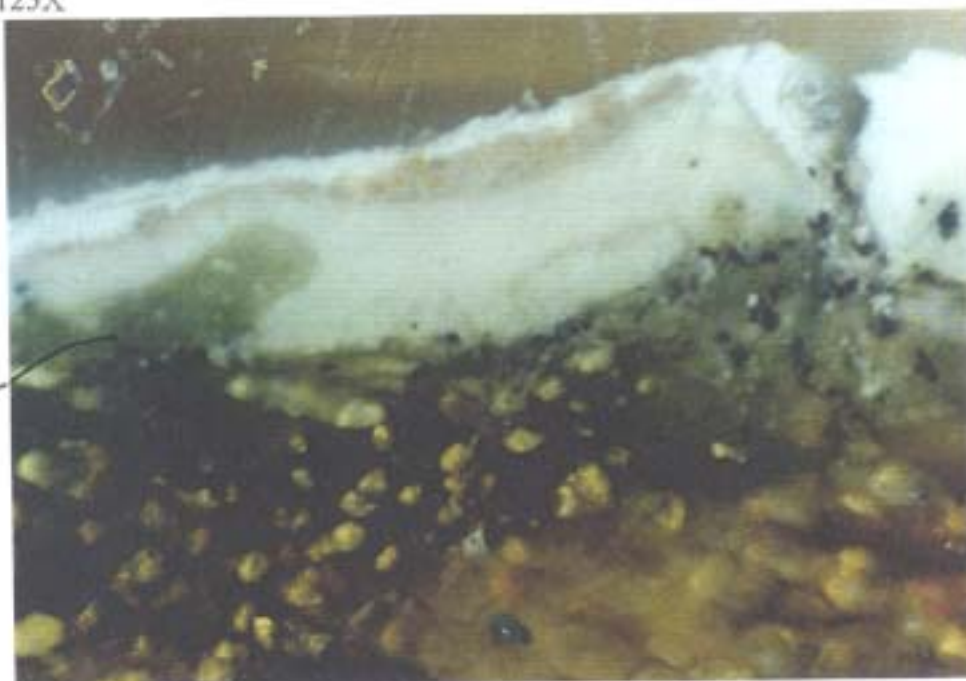
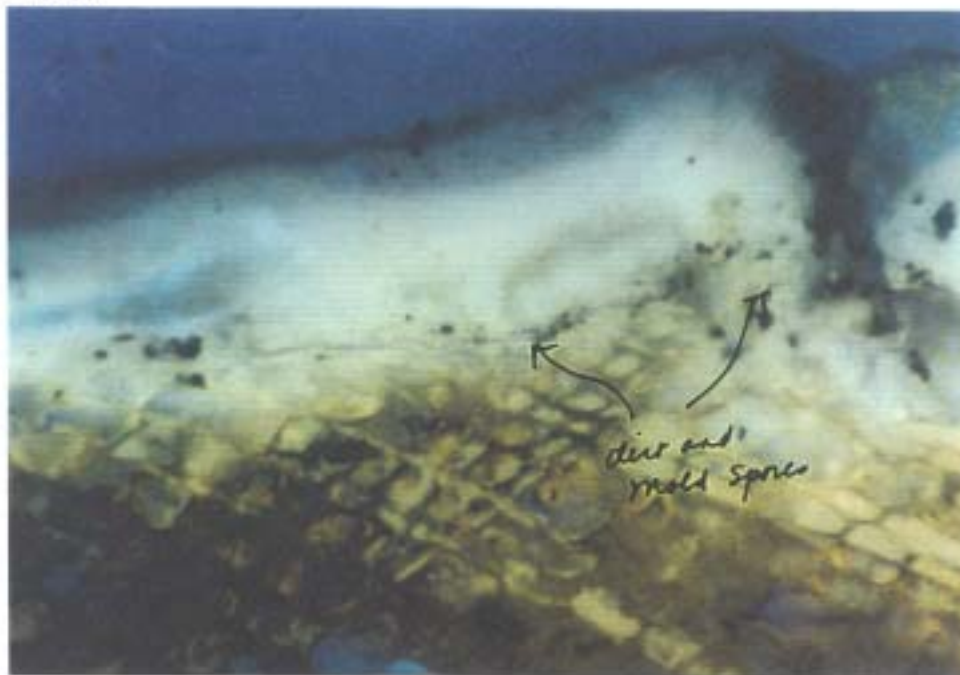
Sample E02: South Wing First Floor/Southeast Window Frame SE, 1834

Sample E02: South Wing First Floor/Southeast Window Frame SE, 1834. The evidence in this cross-section suggests there is no early paint remaining on this element, but there does appear to be residues of an early resinous coating on the wood. The surface of the wood substrate is darkened, dirty and there are mold spores trapped in the resinous coating. Perhaps this resinous coating (a plant resin varnish) was applied as a sealant or a waterproofing agent before the frame was painted. The cross-section evidence indicates the early paint on this window frame weathered completely away and the window frame was left unpainted for a long period of time. There are remnants of a more recent off-white paint, followed by a pinkish-tan paint, and then a modern white paint layer with an off-white primer as the current coating.

remnants
coating
or
sealant

*residual
material*

*discolor
and
mold spores*

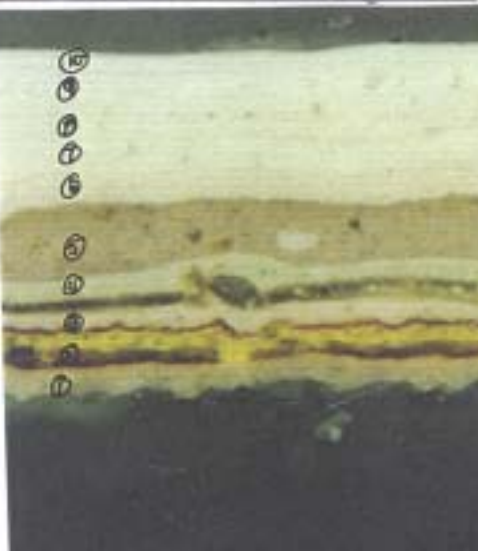
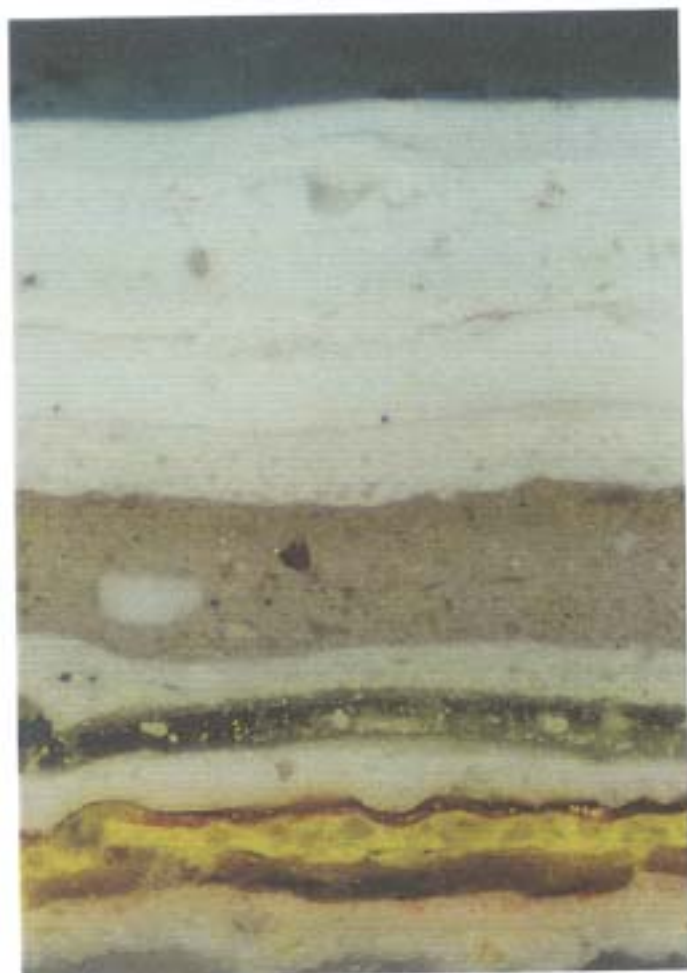
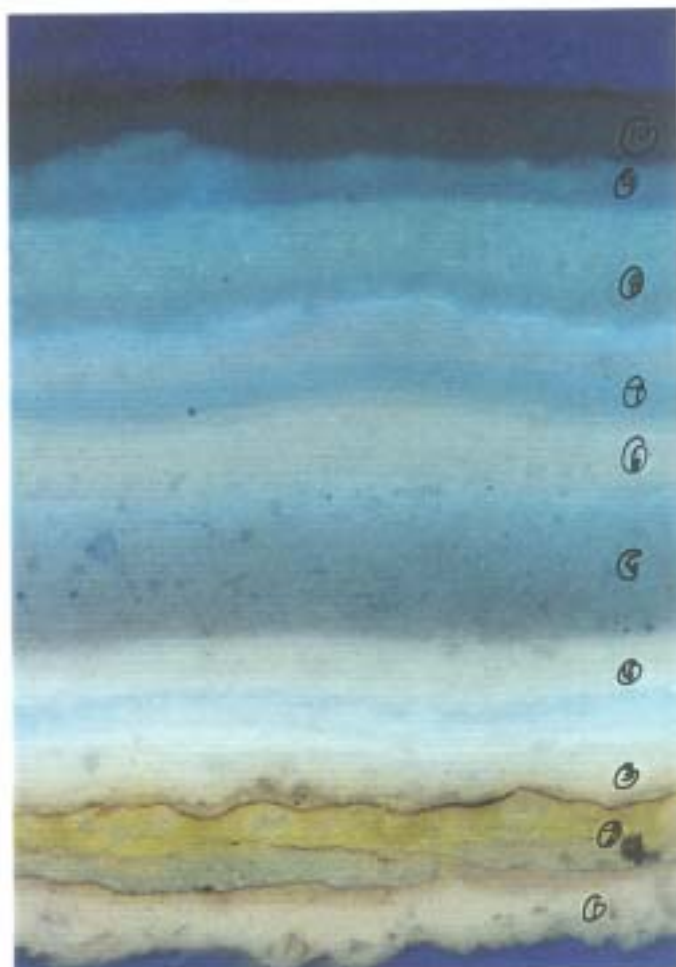
Sample E03: East Wing First Floor/Kitchen Door Jamb Panel SE, 1834

Sample E03: East Wing First Floor/Kitchen Door Jamb Panel SE, 1834. This cross-section contains ten generations of paint, beginning with graining treatments in the first and second generation. The first generation consists of an off-white primer, a pinkish base coat, a brown glaze and a plant resin varnish coating. This could represent a graining treatment to imitate a wood such as mahogany or cedar. The second graining treatment has a yellow base coat, a red-brown glaze and a plant resin varnish coating, and it may be an imitation of a lighter colored wood such as oak.

Generations five through ten appear to be modern paints as the pigments are finely ground and evenly dispersed, and the layers are nonfluorescent in reflected ultraviolet light.

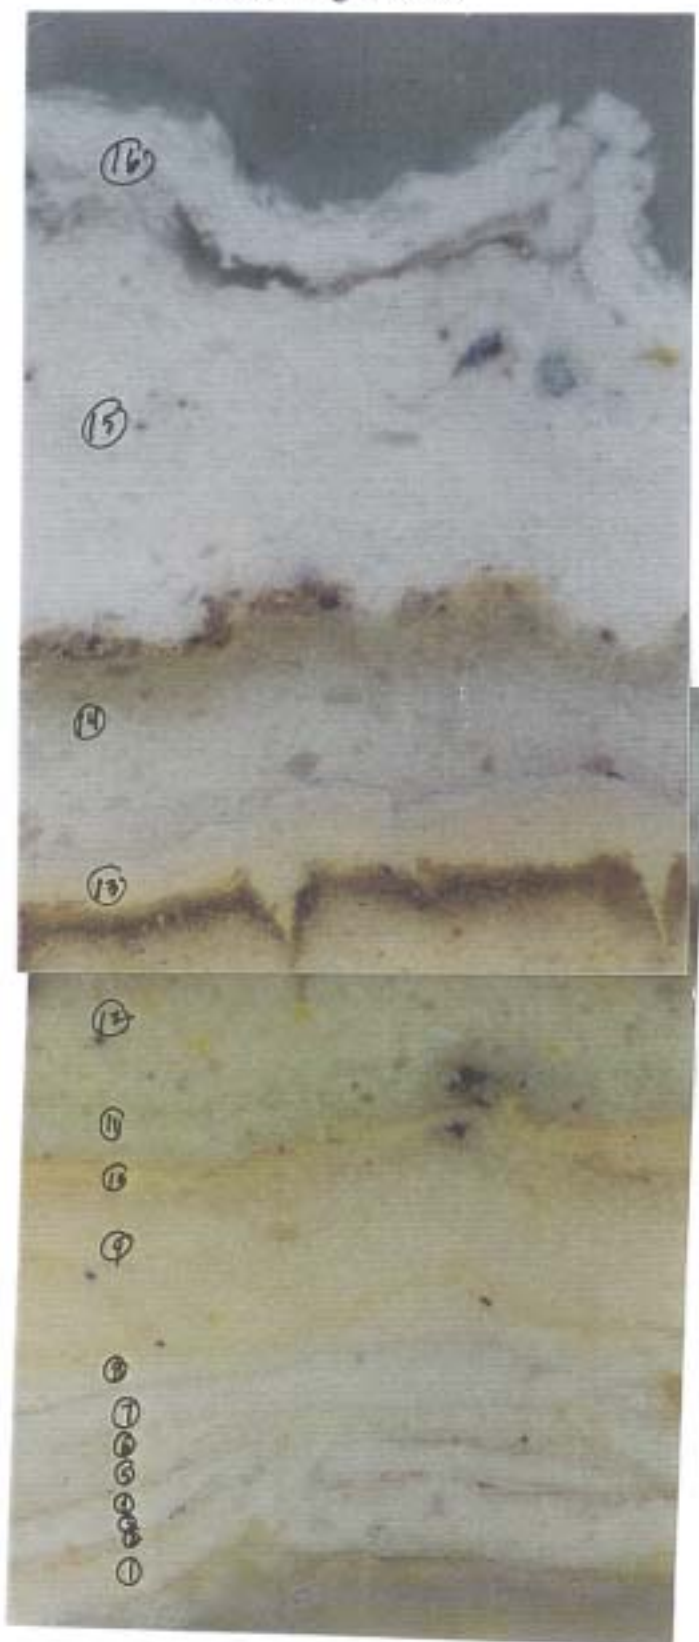
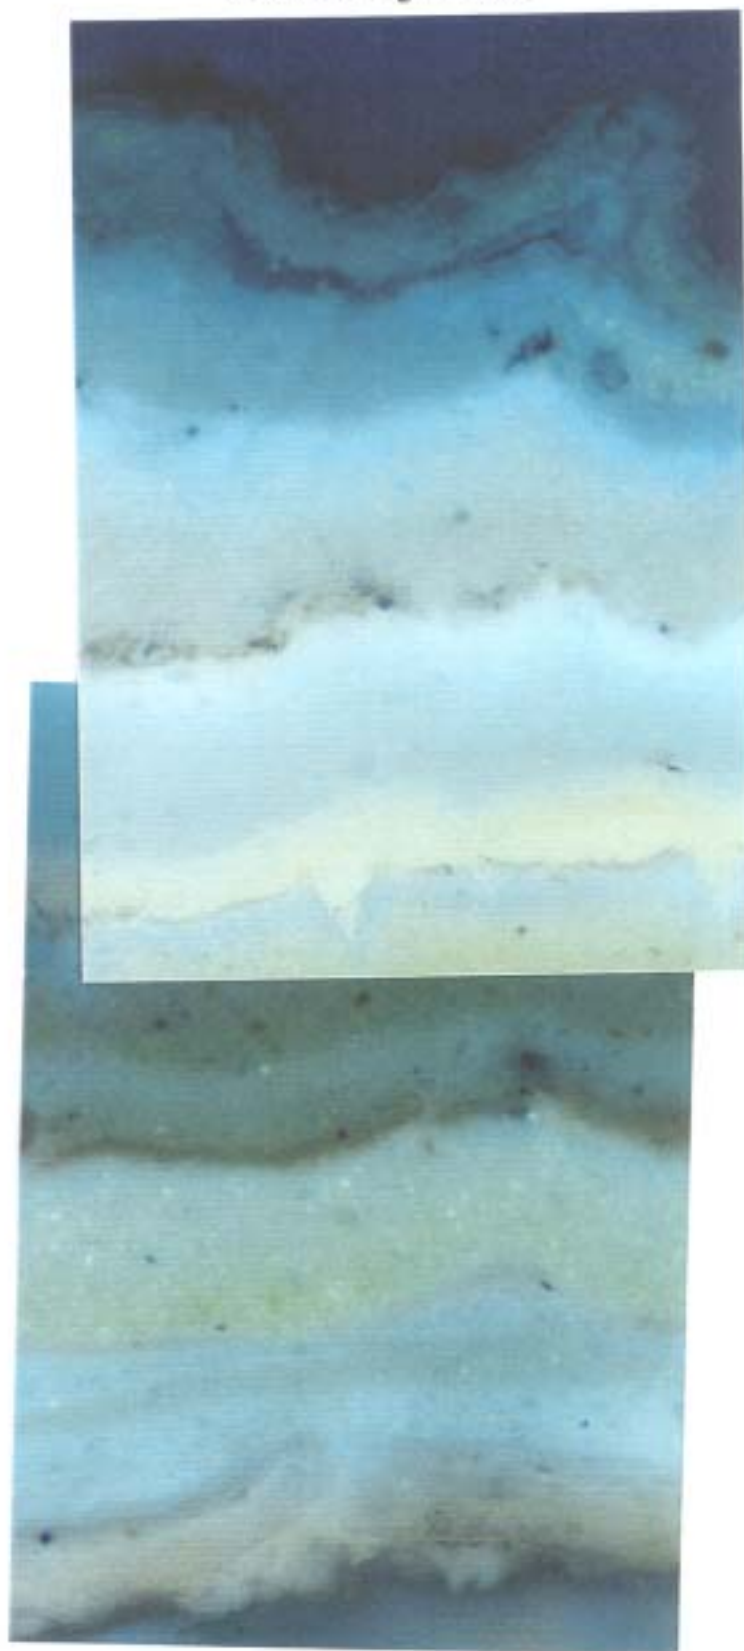
Sample E04: East Wing First Floor/Arch Column SE, later. The column was identified by Eloise Marinos as being a later element, yet the paint history in the cross-section from the column contains considerably more paint layers than the other five exterior elements sampled for this study. There are approximately sixteen generations of paint beginning with nine generations of white and off-white paint.

The only comparatively early paint layer that can be lined up with the paint sequence in sample E03 from the 1834 kitchen door jamb is the coarse off-white paint in generation 11 in sample E04. This appears to be the same layer (with a sparkly appearance in the UV) as the off-white paint identified as generation 4 in sample E03. This suggests there are many earlier paint layers missing from sample E03 since the kitchen door jamb presumably predates the column, it should contain more early paint layers.

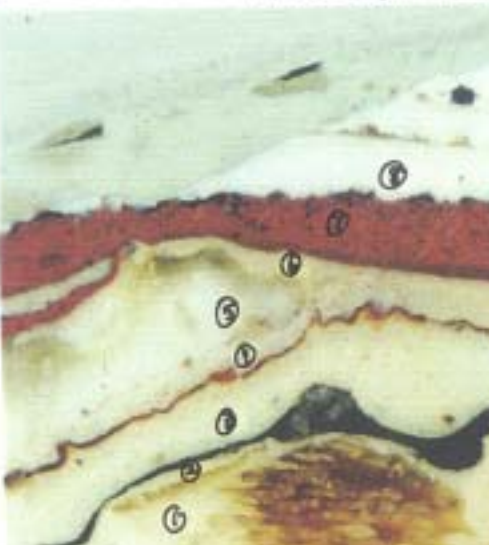
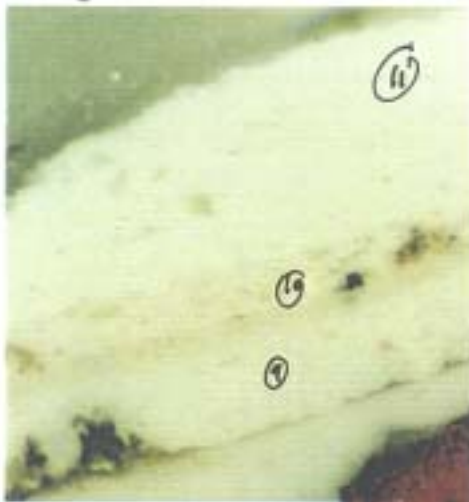
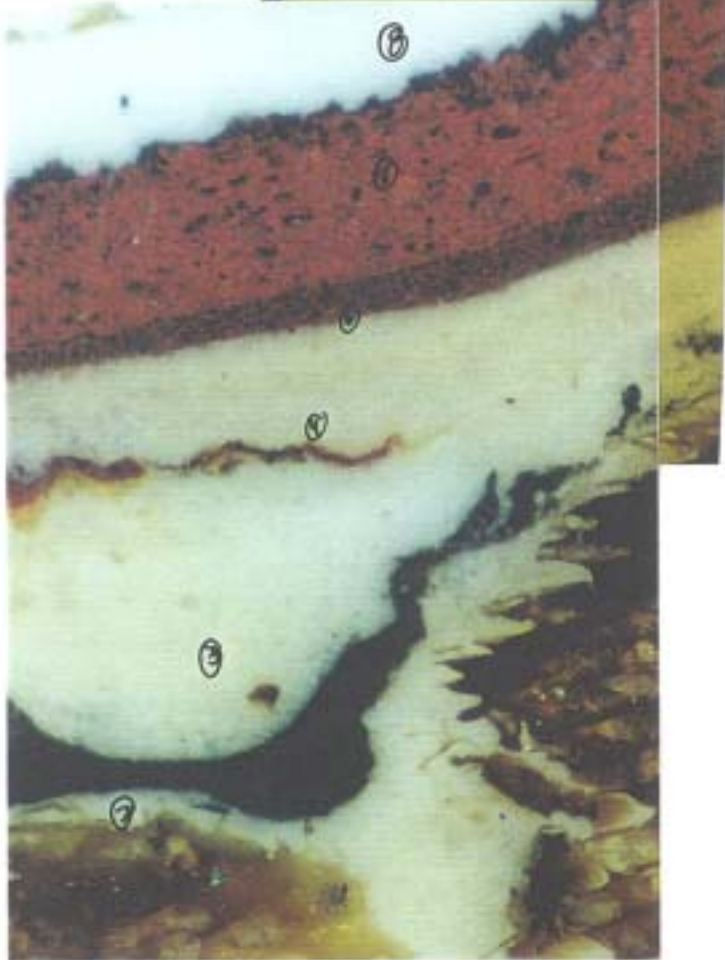
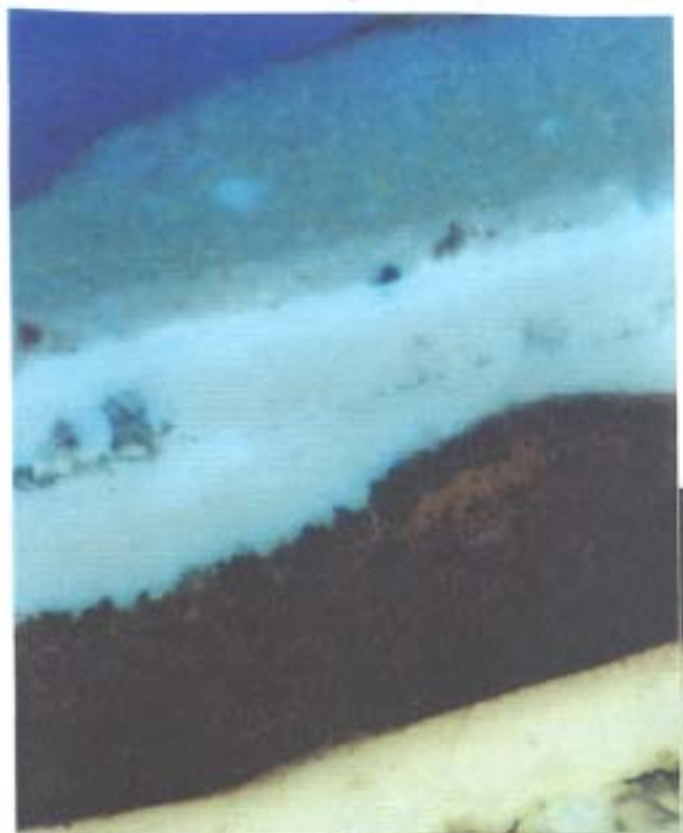
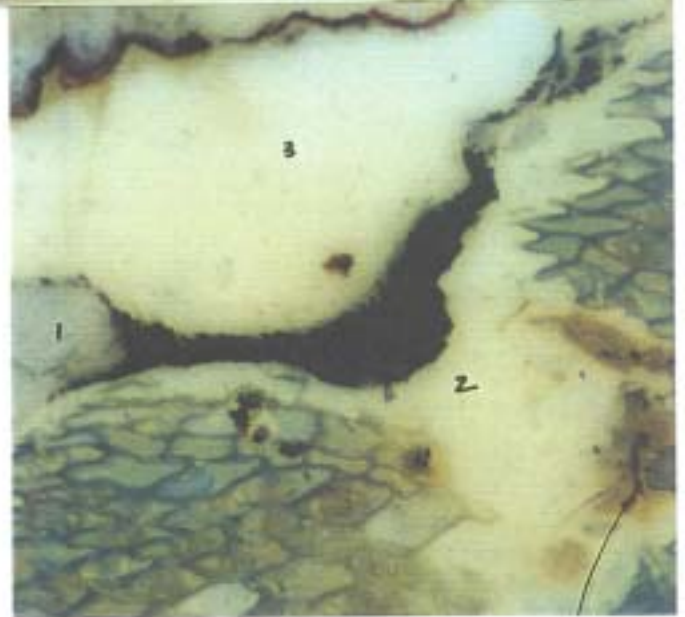
Sample E05: East Wing Second Floor/Upper Sash (12/8) SE 1834-mid 1850's. This sample contains approximately eleven generations of paint, beginning with what appears to be a remnant of the first off-white paint layer with a thin plant resin varnish layer that is trapped in a recess in the wood. The varnish may have been added to increase the durability of the paint surface, as well as to increase the level of gloss. This may be the original paint treatment on the sash, but because of the disturbed nature of the wood substrate, it is difficult to say with certainty that the original paint from the period of 1834 to the mid 1850s survives here. There also seem to be bits of the same type of resinous sealant or varnish trapped in the wood fibers that was found in sample E02 from a south wing window frame.

In the second generation it appears the sash was painted black over a cream-colored primer. The third generation consists of a reddish-brown glaze over cream-colored primer. The sash was also painted red-brown in the sixth and seventh generations. This is the only sample from an exterior frame or sash that provides enough information for color matching. The color match for the first off-white colored paint is included at the end of this report.

resinous material

resinous
material

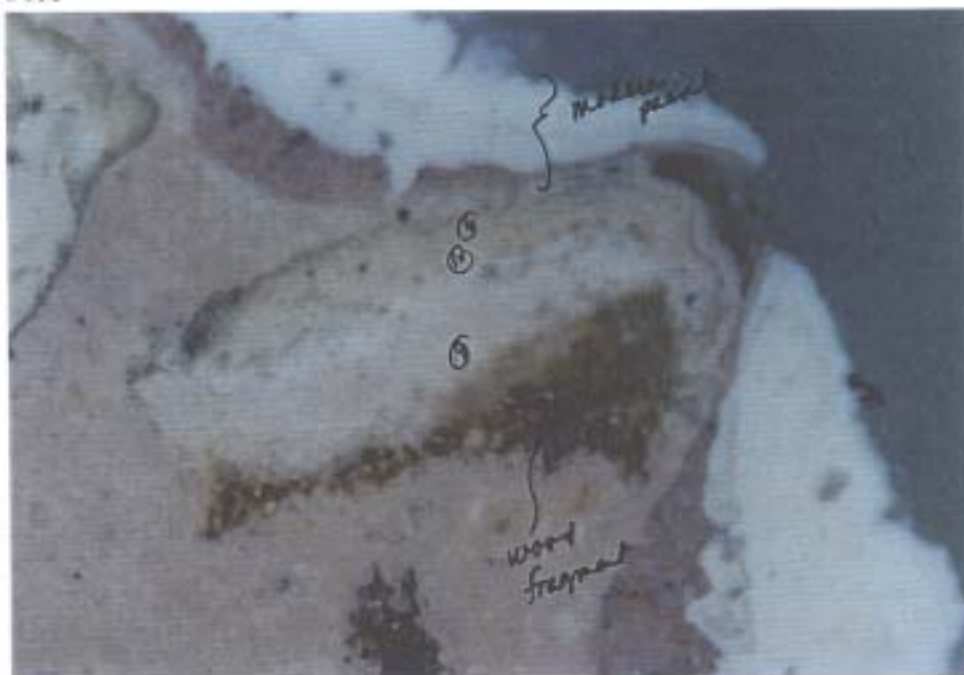
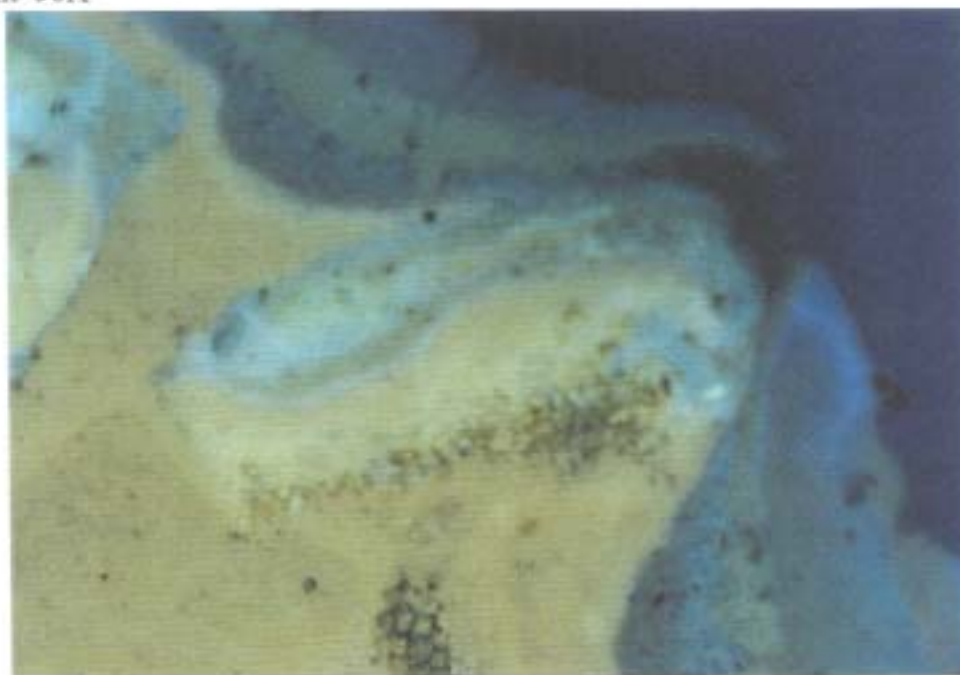
Sample E06: East Wing Second Floor/Window Frame SE, 1834-mid 1850's. The paint sequence on the window frame is disrupted and discontinuous. When the paint sequence in this sample is compared to sample E04 it appears that generations 9, 10 and 11 are preserved above a fragment of wood surrounded by modern paints. This sample does not provide helpful information about the early paint history of this window frame on the east wing.
