ARCHAEOLOGICAL SENSITIVITY SURVEY
Captain Oliver Filley House, Bloomfield, Connecticut

Prepared for: Wintonbury Historical Society
Bloomfield, CT 06002

Prepared by: Archaeological Research Specialists
437 Broad Street
Meriden, CT 06450
(203) 237-4777
(203) 237-4667 FAX/voice

Date: May 1995

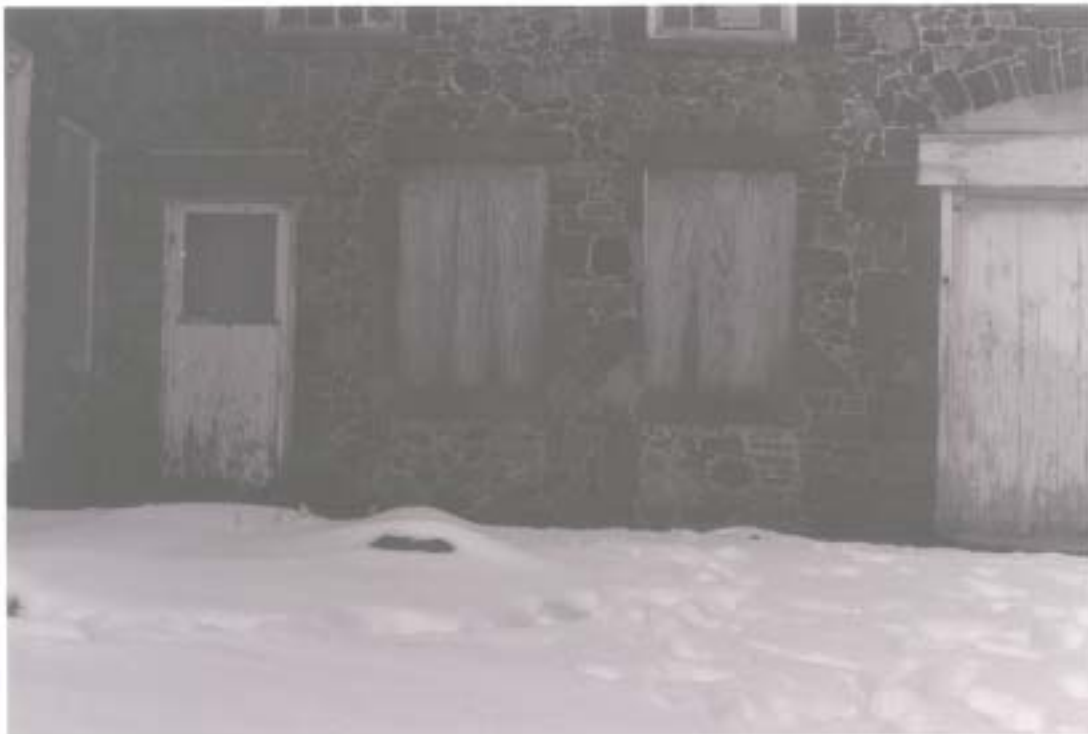
the lower cellar windows. Visual inspection of the ell exterior reveals that the first floor windows have been shortened. Two brownstone lintels, matching the rest of the lintels at the house, and additional faced rubble masonry was added to close the gap between the new ground level and the lower sill of the windows.

This major alteration seriously affected the Minor Wing prior to the construction of the front porch. The lower level cellar windows were sealed with stone and brick, and the land was graded to completely cover these windows. Then, the first floor kitchen windows were shortened by nearly twelve inches. A photograph dating to 1885 shows that the cellar windows were completely obscured by this time, and the first floor windows to be at the same level as the corner ell doorway.

2. Close up of the front (kitchen) window alteration

At what time was the cellar stairway added, lower level windows filled in, and southeastern yard filled in? Trenching of the front yard in order to study the stratigraphy will address these and other questions. There will be a buried topsoil under the fill somewhere. Sample screening of the trench backdirt and careful profiling of each trench wall may yield diagnostic artifacts which can conclusively date individual filling episodes.

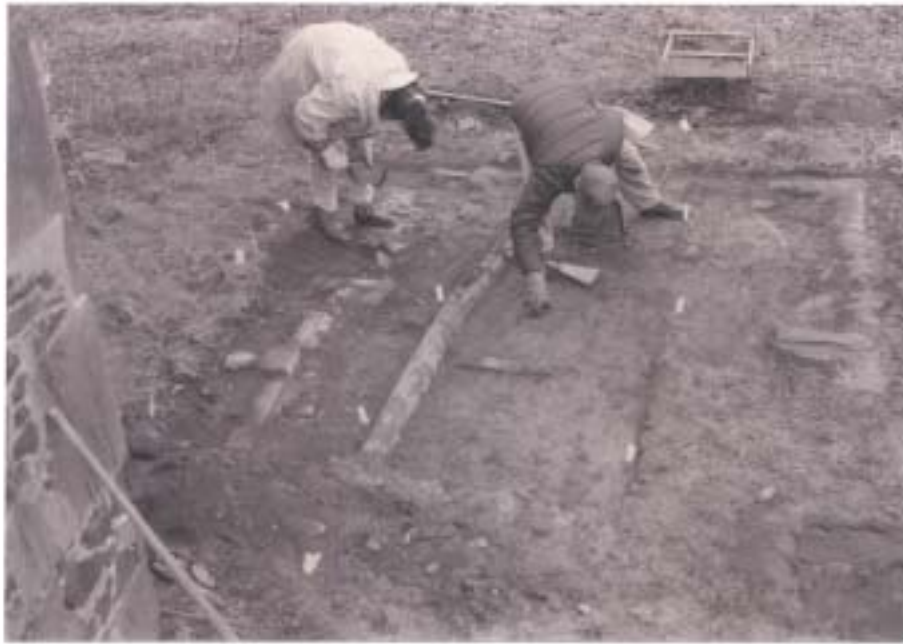
On the northwest corner of the Major Wing a small structure had been added. Visible roof lines and a cut stone foundation are barely evident but sufficiently outline the structure. A doorway, now blocked with brick, exited the northwest wall of the kitchen ell into this addition. A drainage pipe from a more recent occupation runs through the center of the foundation and may minimally affect the structure's overall integrity. ARS initiated the excavation of the remains of this brick and stone foundation in November of 1994. By completely exposing, mapping and archaeologically testing this feature, we hoped to gain information regarding the nature and function of this addition. Nine 1 m² excavation units were partially excavated so that the entire foundation and floor of this addition could be exposed. Extensive cartographic and photographic documentation procedures were conducted (Photograph 3, Figure 5).

The addition on the northwest corner of the Major Wing is also a mystery. We have defined the outline of the foundation through troweling and cleaning, and visual

inspection proves that there was indeed a doorway from the kitchen into this addition. Further testing of this structure should reveal artifacts which may help to define the function and period of this structure. It is possible that this addition may have been a summer kitchen, or perhaps a rear entryway into the service wing. However, the lack of temporally and functionally diagnostic artifacts within the artifact assemblage, do not allow for a positive identification/interpretation of this structure. Most significant in regards to this feature is the high degree of integrity we have determined to be associated with this period of occupation at the Captain Oliver Filley House.

3. Archaeological excavation of addition at northwest corner.

Why was the addition built at the northwest corner of the house and when was it destroyed? Might said addition have sealed any domestic/trash deposits or cultural features (such as a well or cistern) which may have been placed in close proximity to the kitchen? Should further testing be undertaken at some future date, ARS recommends removal of the aggregate floor within this addition, and shovel shaving 100% of the surface area in 2 to 4 inch levels to the junction between topsoil and subsoil levels. Minimal testing should be conducted below this interface (i.e., at least two levels of sterile subsoil will be excavated within 50 cm² STPs placed at 6 to 15 foot intervals).

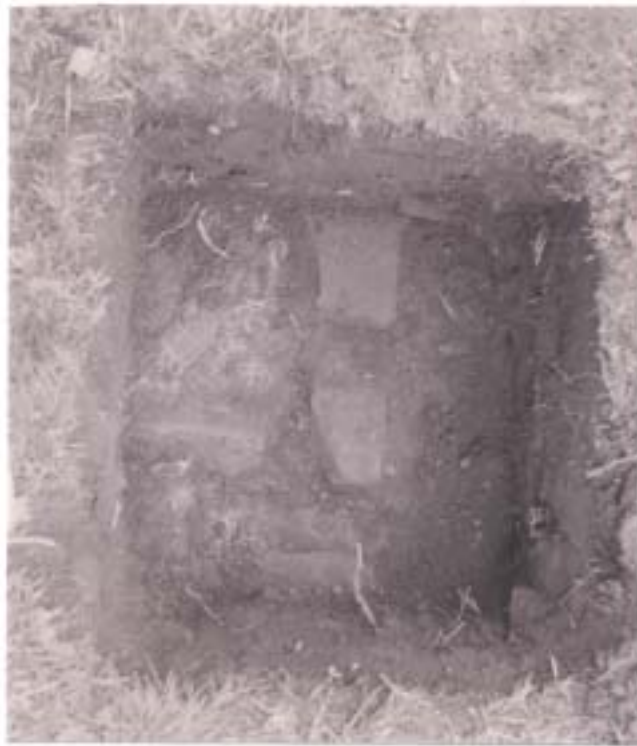
Interestingly, archaeological testing in this area also located a much deeper foundation, of unknown function, below the 1880s porch. A linear arrangement of stones and brick seem to confine an aggregate living floor and possible domestic debris. This foundation is dry-laid and smooth-finished on the outside and rough on the inside.

proposing the possibility that it was exposed and visible at an earlier date. This foundation could have supported an earlier porch, one built prior to the regrading of the property. The depth at which this feature was uncovered (38 cm BS) and lack of continuity with above strata, tend to substantiate hypotheses concerning a major filling episode(s) and/or change in grade within the southeastern portion of the Filley House area (see discussion of the minor wing's arched entry for further information in this regard).

Beginning at the 40 cm level, and continuing for an unknown depth, was the unit's second major feature, a cut stone foundation. The foundation does not continue laterally into Unit T1-3, which is only 2 meters north of T1-5; however, significant disturbances were noted in the SE quad of T1-3 during excavation of the lower fill stratum. The foundation may in fact have been removed at this locale. The foundation is dry-laid and smooth-finished on the outside and rough on the inside, proposing the possibility that it was exposed and visible at an earlier date. The upper fill strata did not appear disturbed above this foundation, hence there can be no association between the 1880s porch and this lower structure. This foundation could have supported an earlier porch, one built prior to the regrading of the property. Alternatively, this foundation could have been an earlier structure unassociated with the present Filley House.

4. 50 cm² STP T1-5 and lower, *finished stone* foundation wall, facing north.

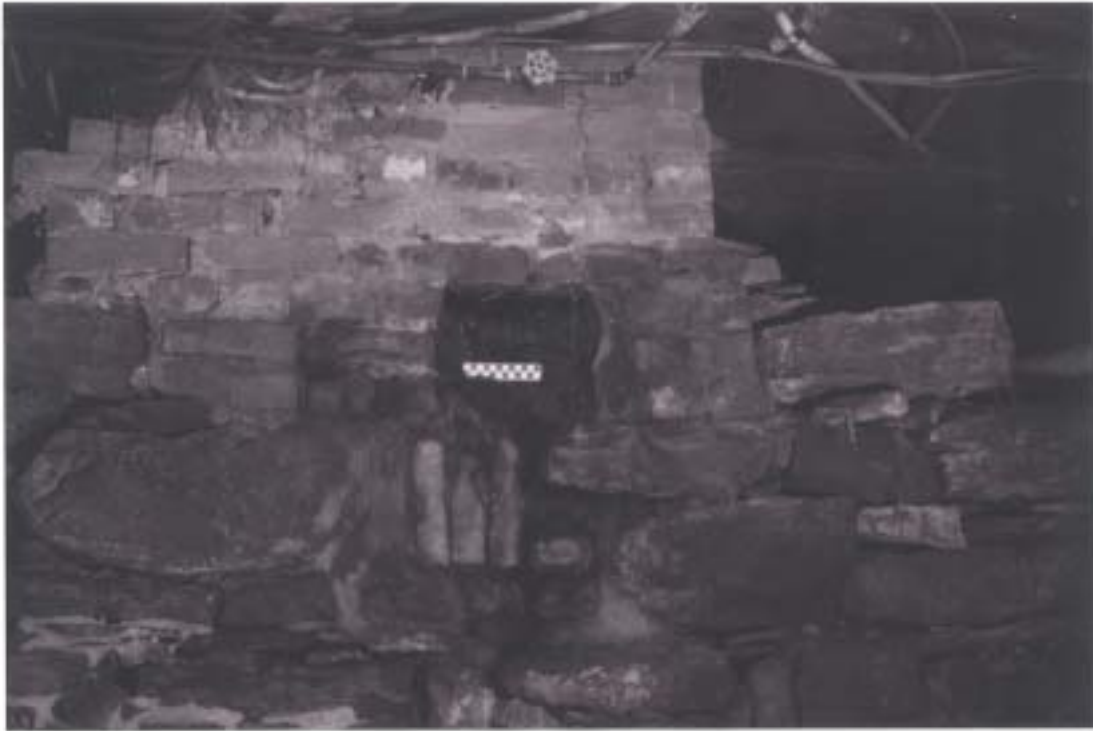
5. Original kitchen chimney stack, basement view.
